Appendix A: San Francisco River Photos – Gila National Forest

These photos accompany our request for closure to demonstrate both the outstanding ecological values associated with this area, as well as the ongoing damage due to ORV use in riparian areas. All photos were taken October 6 or 7, 2007 by Chris Kassar and all GPS points were taken using NAD 27 Datum. The photo point numbers match up with the red triangles found on the associated map of the area (Appendix C: Map #3- Gila NF Photo Points).

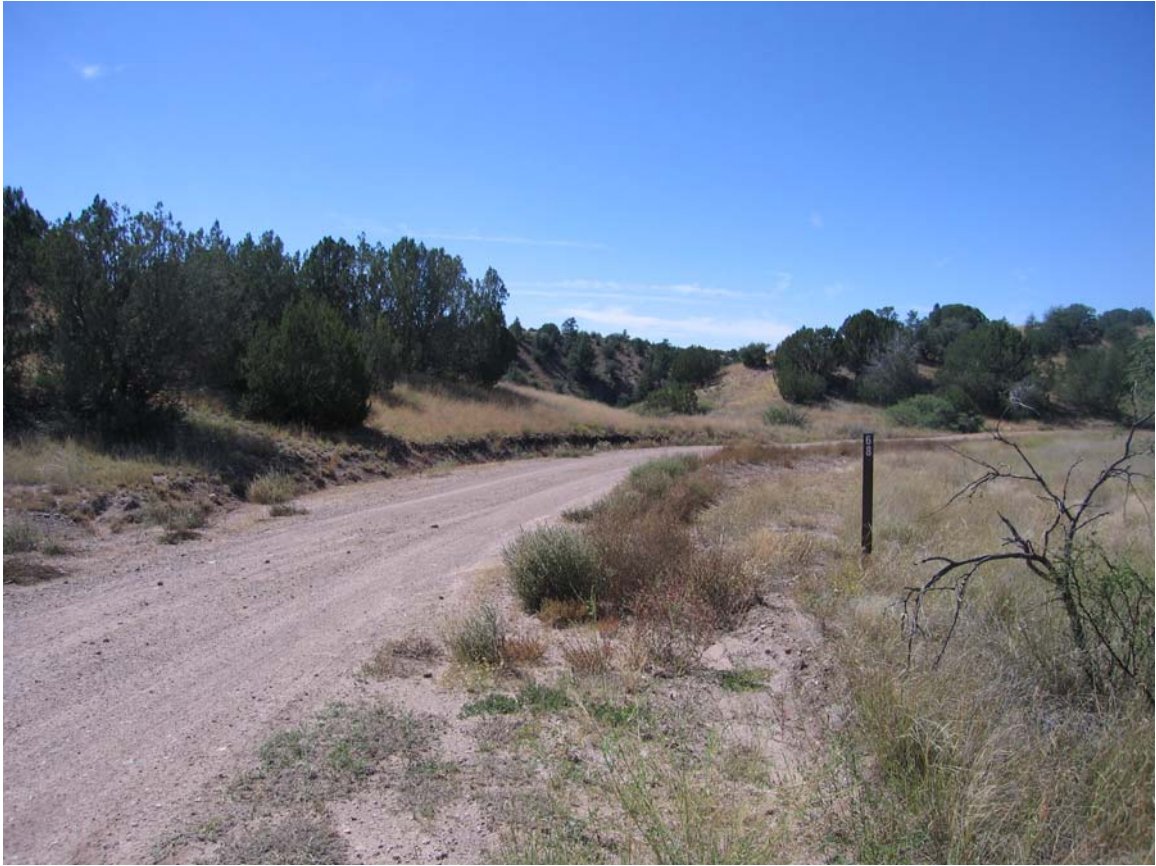
Photo 1.12S 0702273//UTM 3674742 - FR 68 heading west toward Big Dry Creek from intersection with Hwy 180.

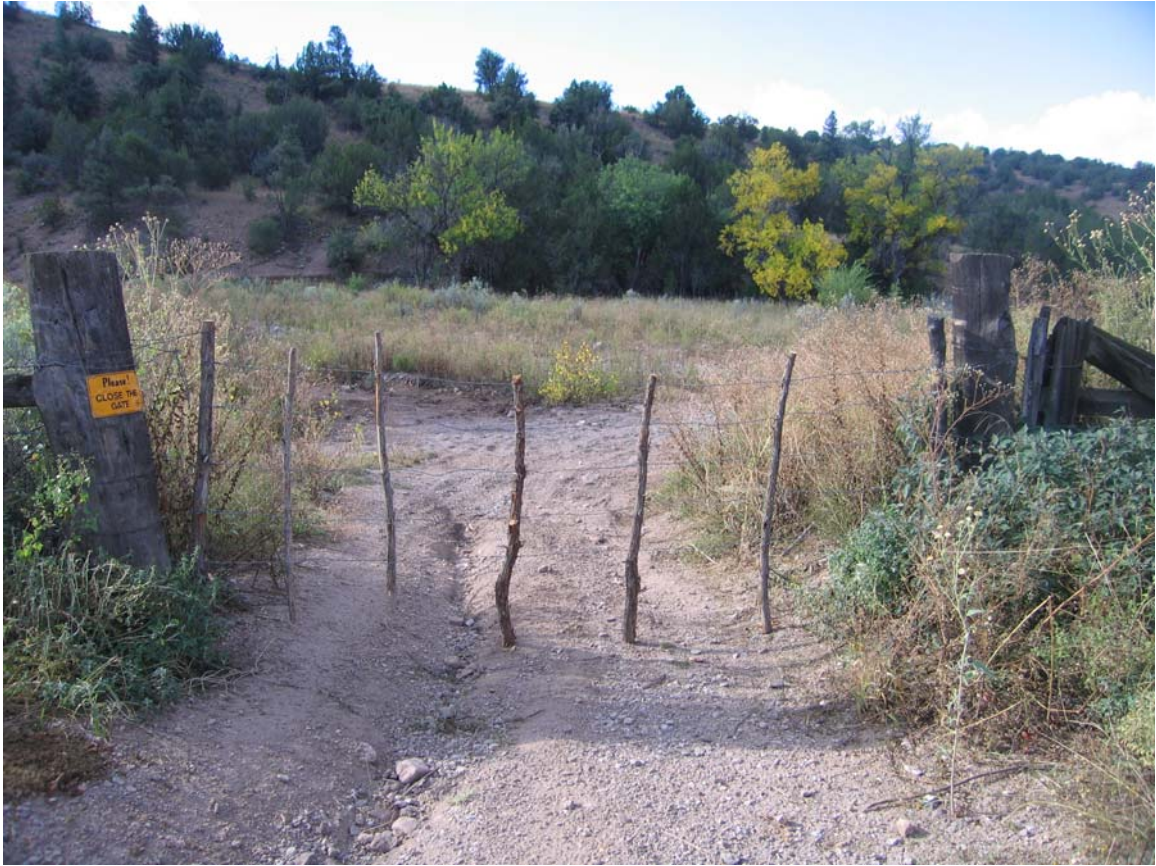
Photo 2. 12S 0701434//UTM 3674384 - Gate on FR 68 separating Gila National Forest property from private property. Route travels into and becomes Big Dry Creek.

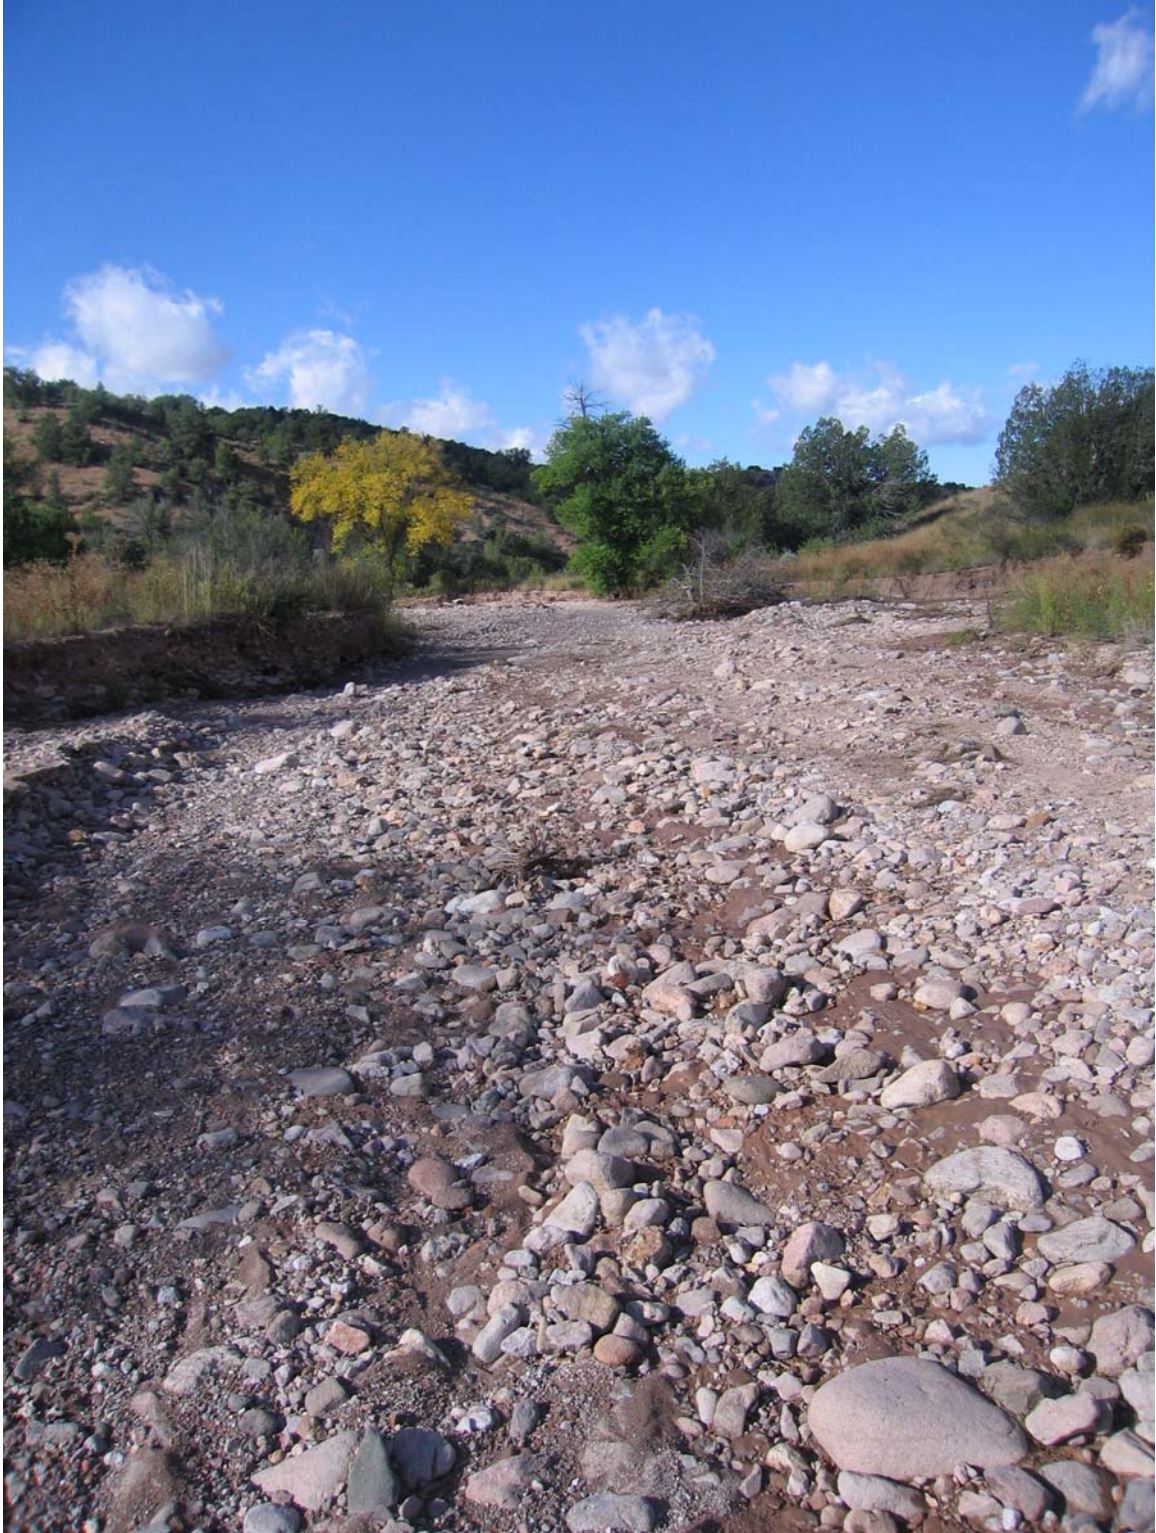
Photo 3. 12S 0701227//UTM 3674354 – Further down Big Dry Creek where road and the creek are the same . Signs of recent use, including quad tracks, cow prints and scat.

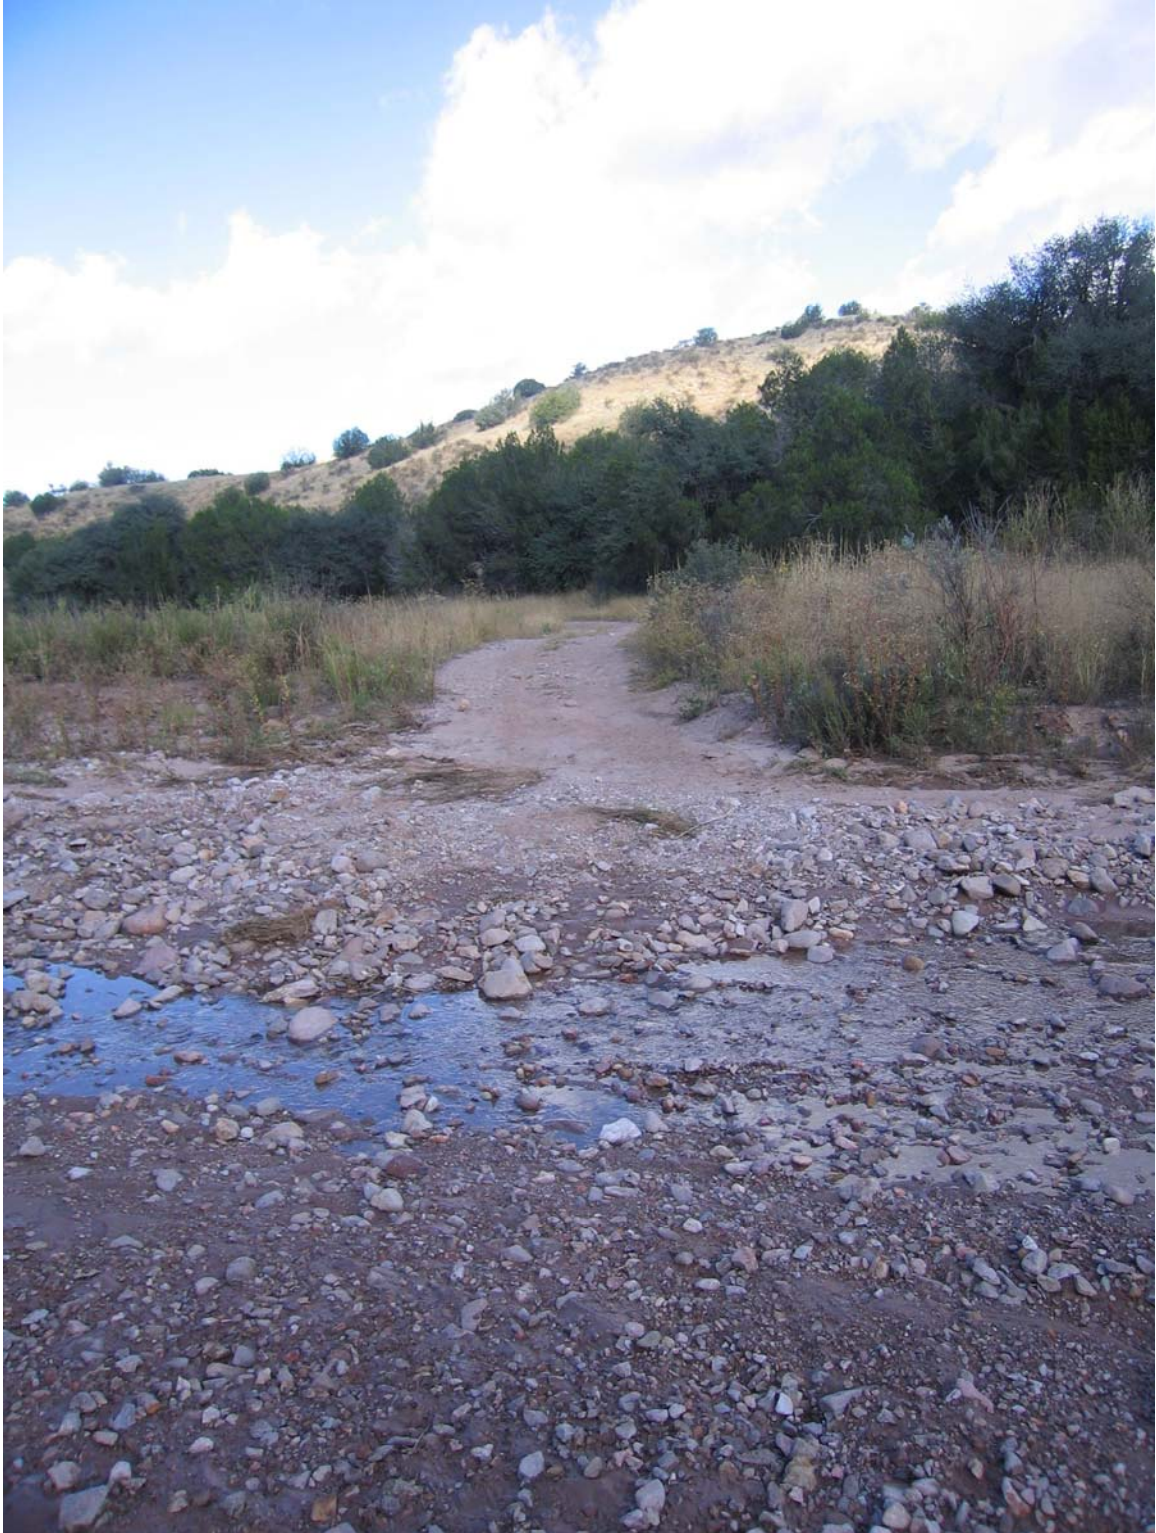
Photo 4. 12S 0700960//UTM 3674209 – First intersection with water on this trip.

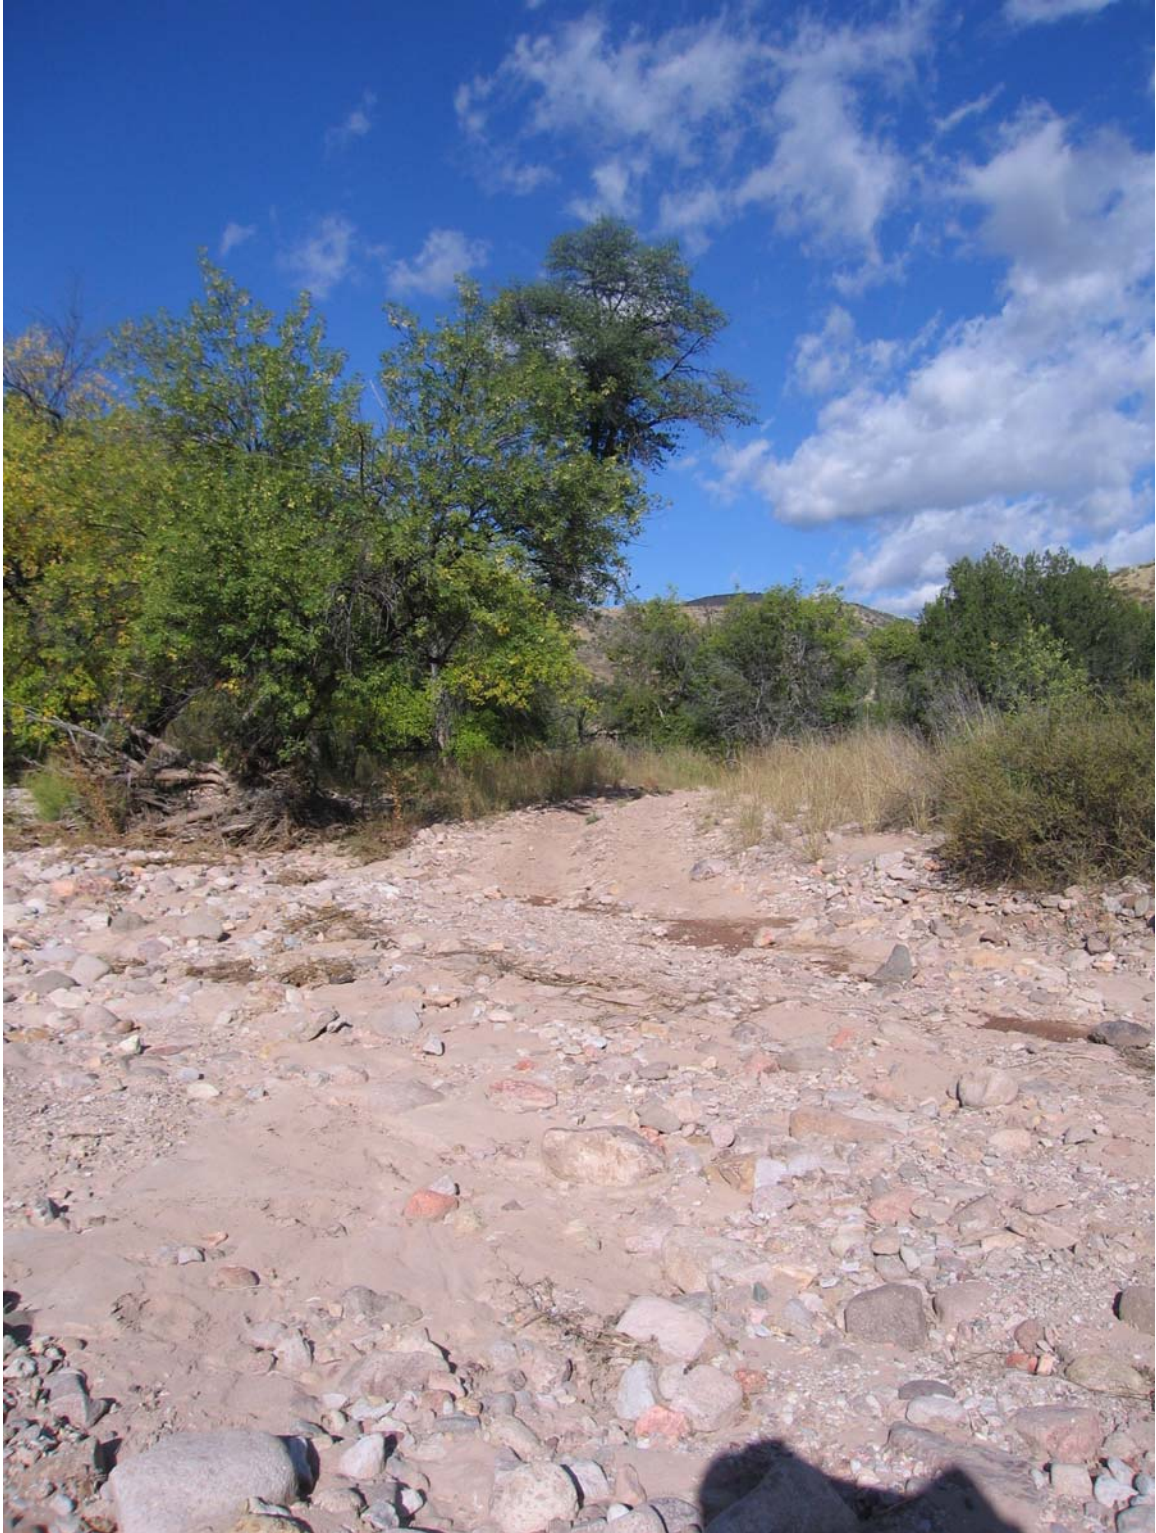
Photo 5. 12S 0700152//UTM 3674156 – Vehicle tracks continue to travel in and out of the creek. Noted erosion and cut banks of 1 to 2 feet. Many birds and small mammals present including Gila and Acorn woodpeckers, squirrels and rabbits.

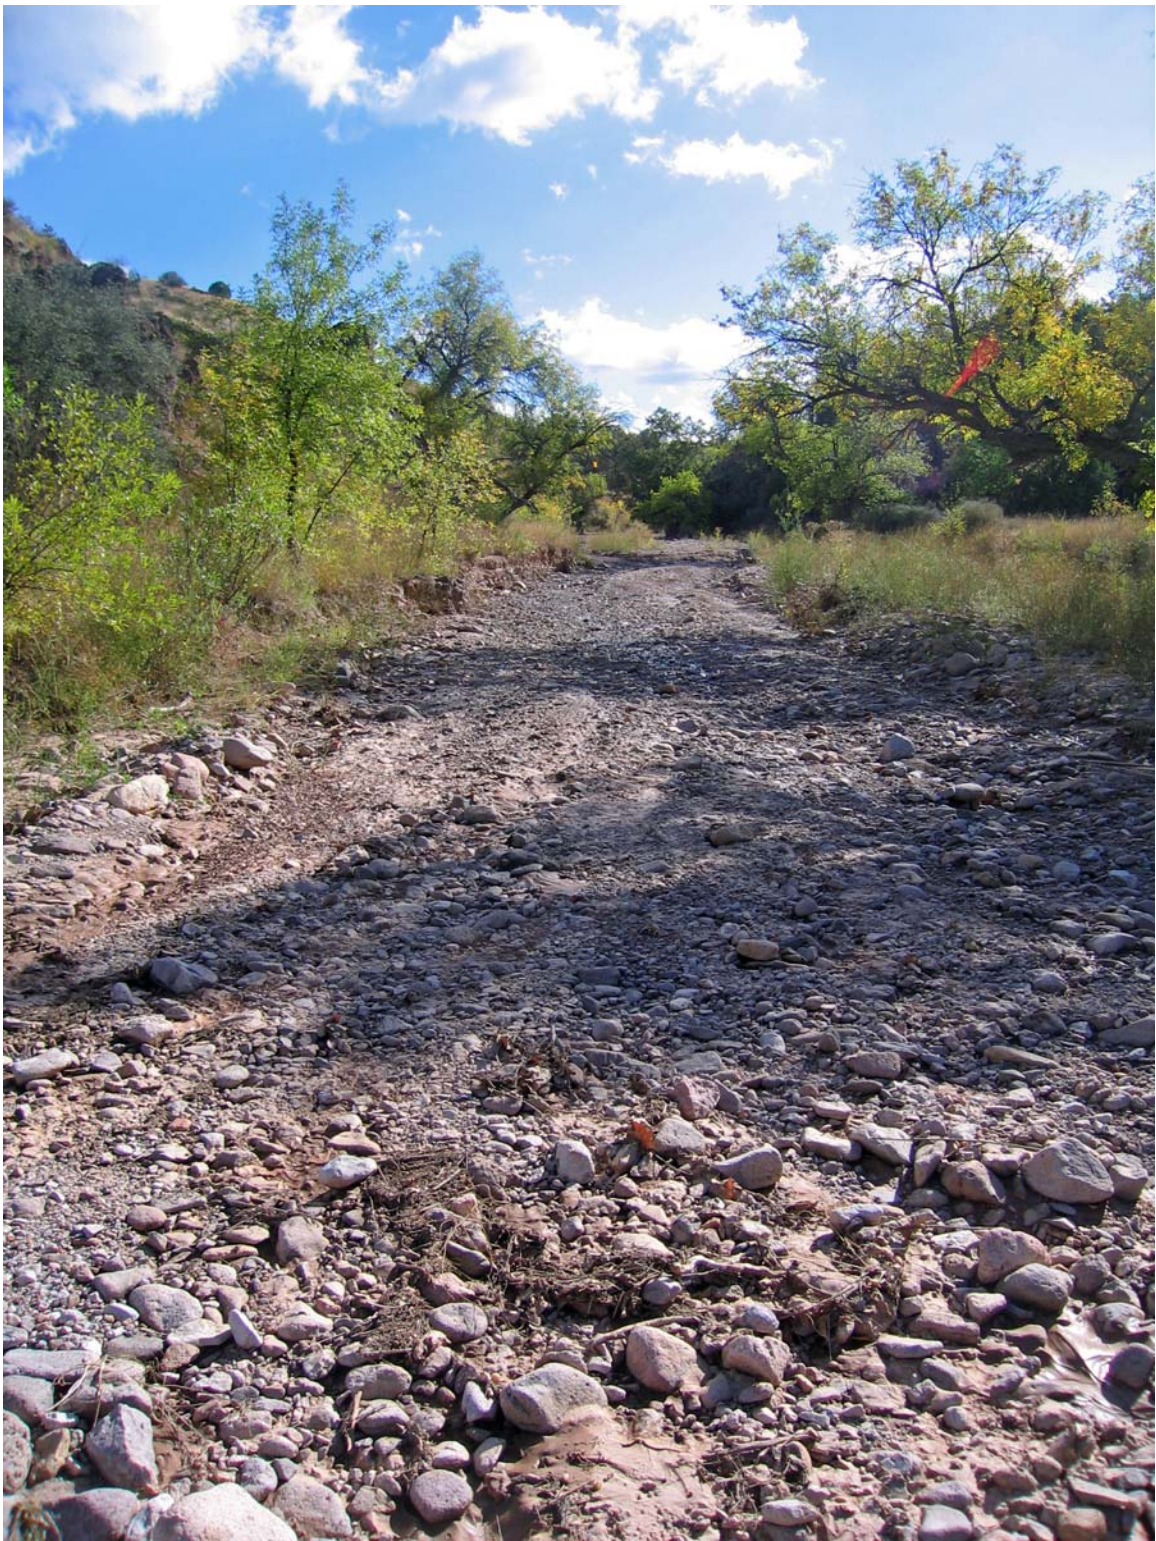
Photo 6. 12S 0700152//UTM 3674156 – Tracks continue down the creek bed. Evidence of erosion, bank cutting and rutting.

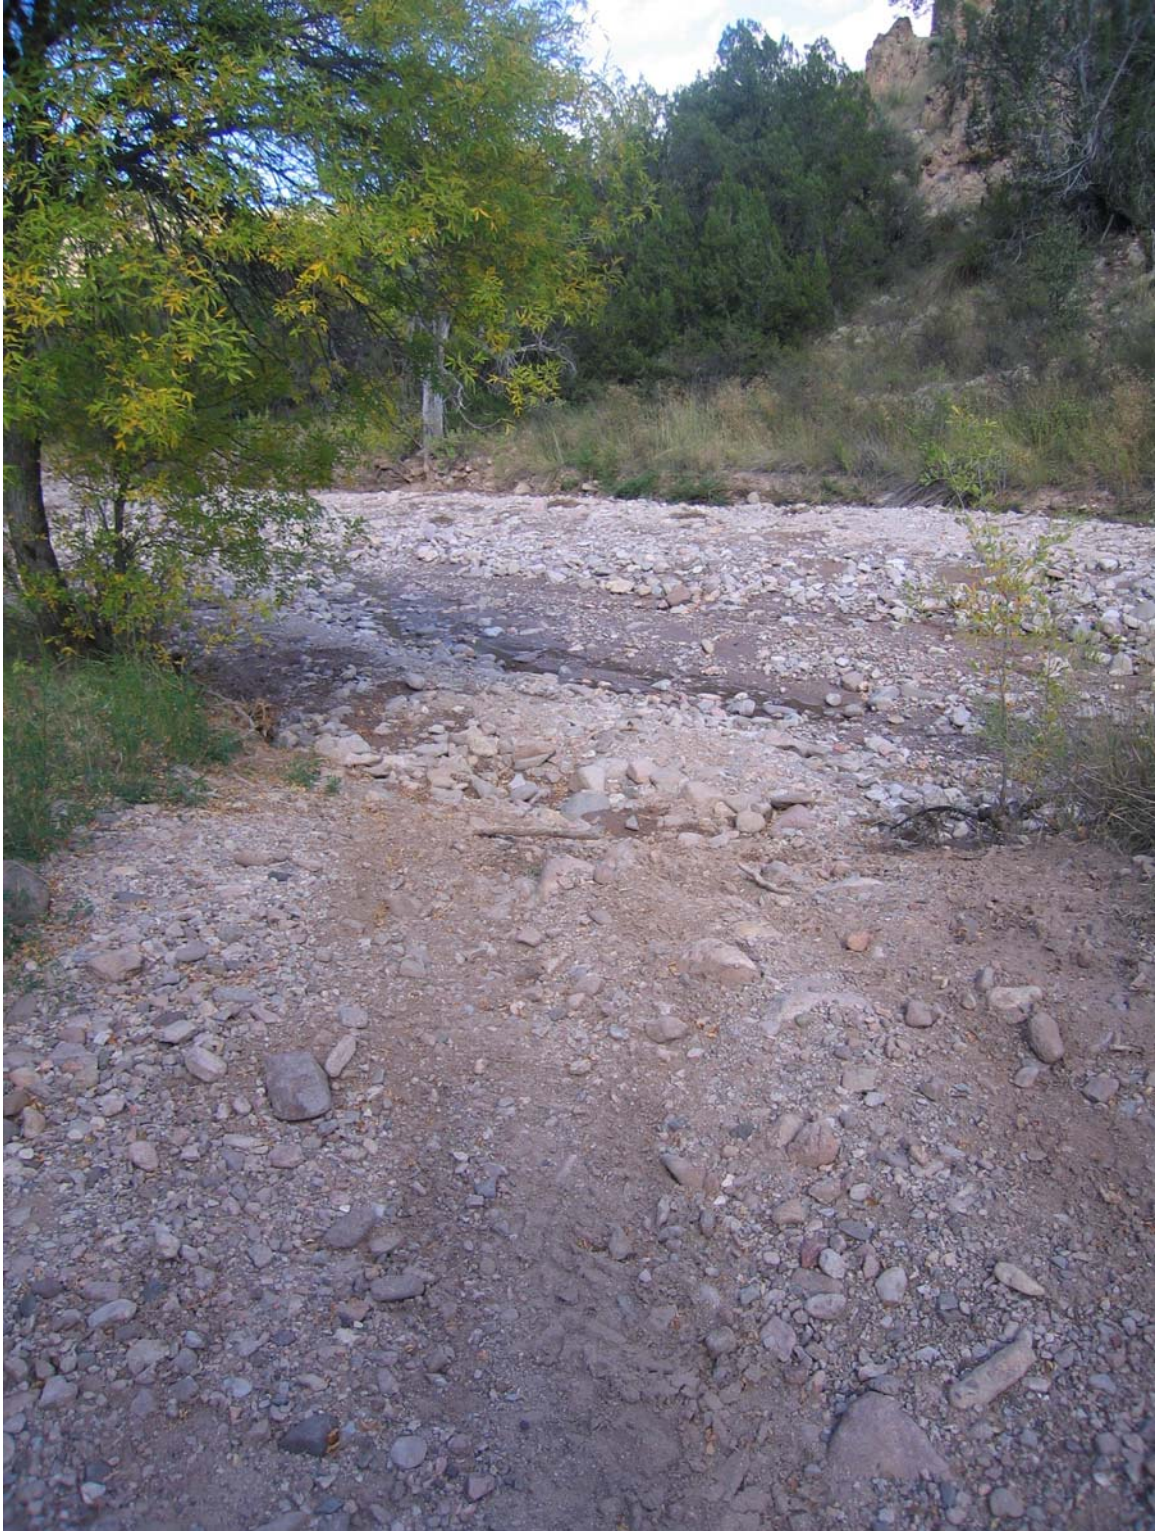
**Photo 7. 12S 0699939//UTM 3674252 - Tracks continue down wash.
Note erosion and sedimentation when route enters the creek.**

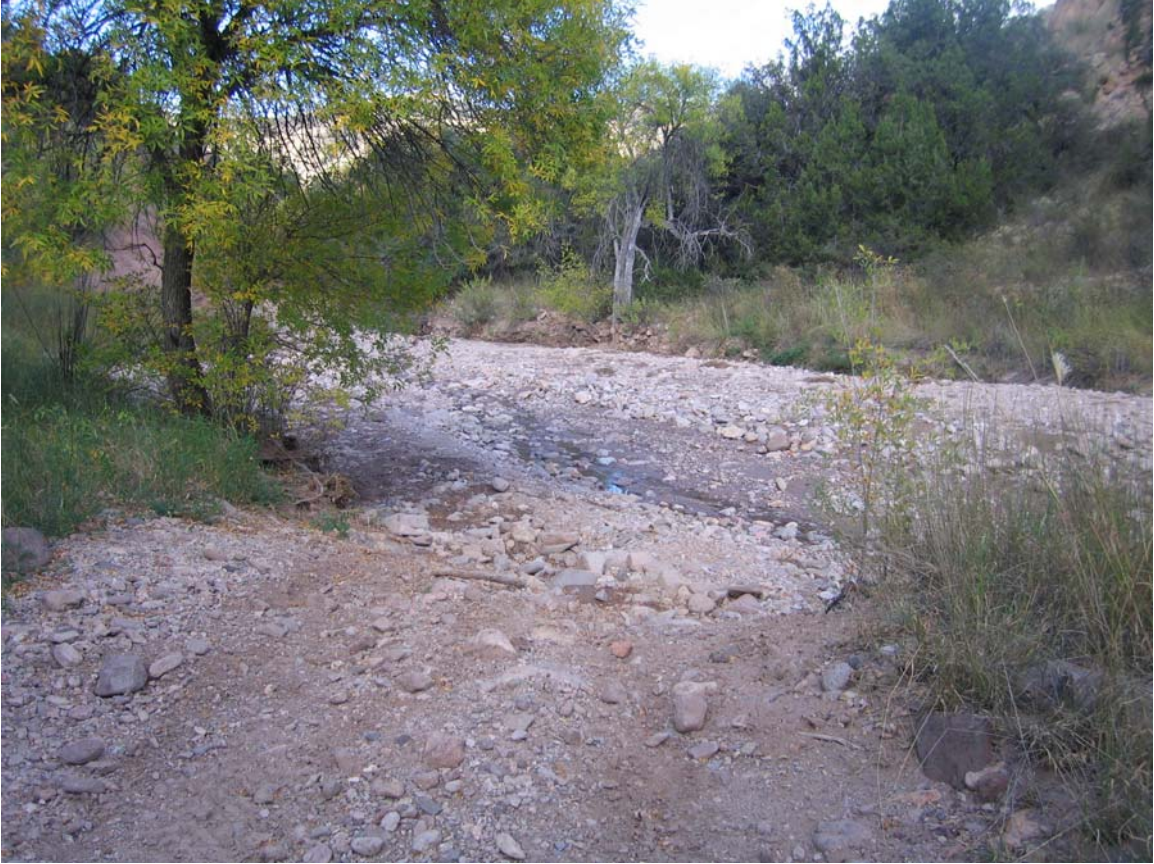
Photo 8. 12S 0698967//UTM 3675279 – Tracks traveling into creek causing cut banks and runoff of sediment into creek.

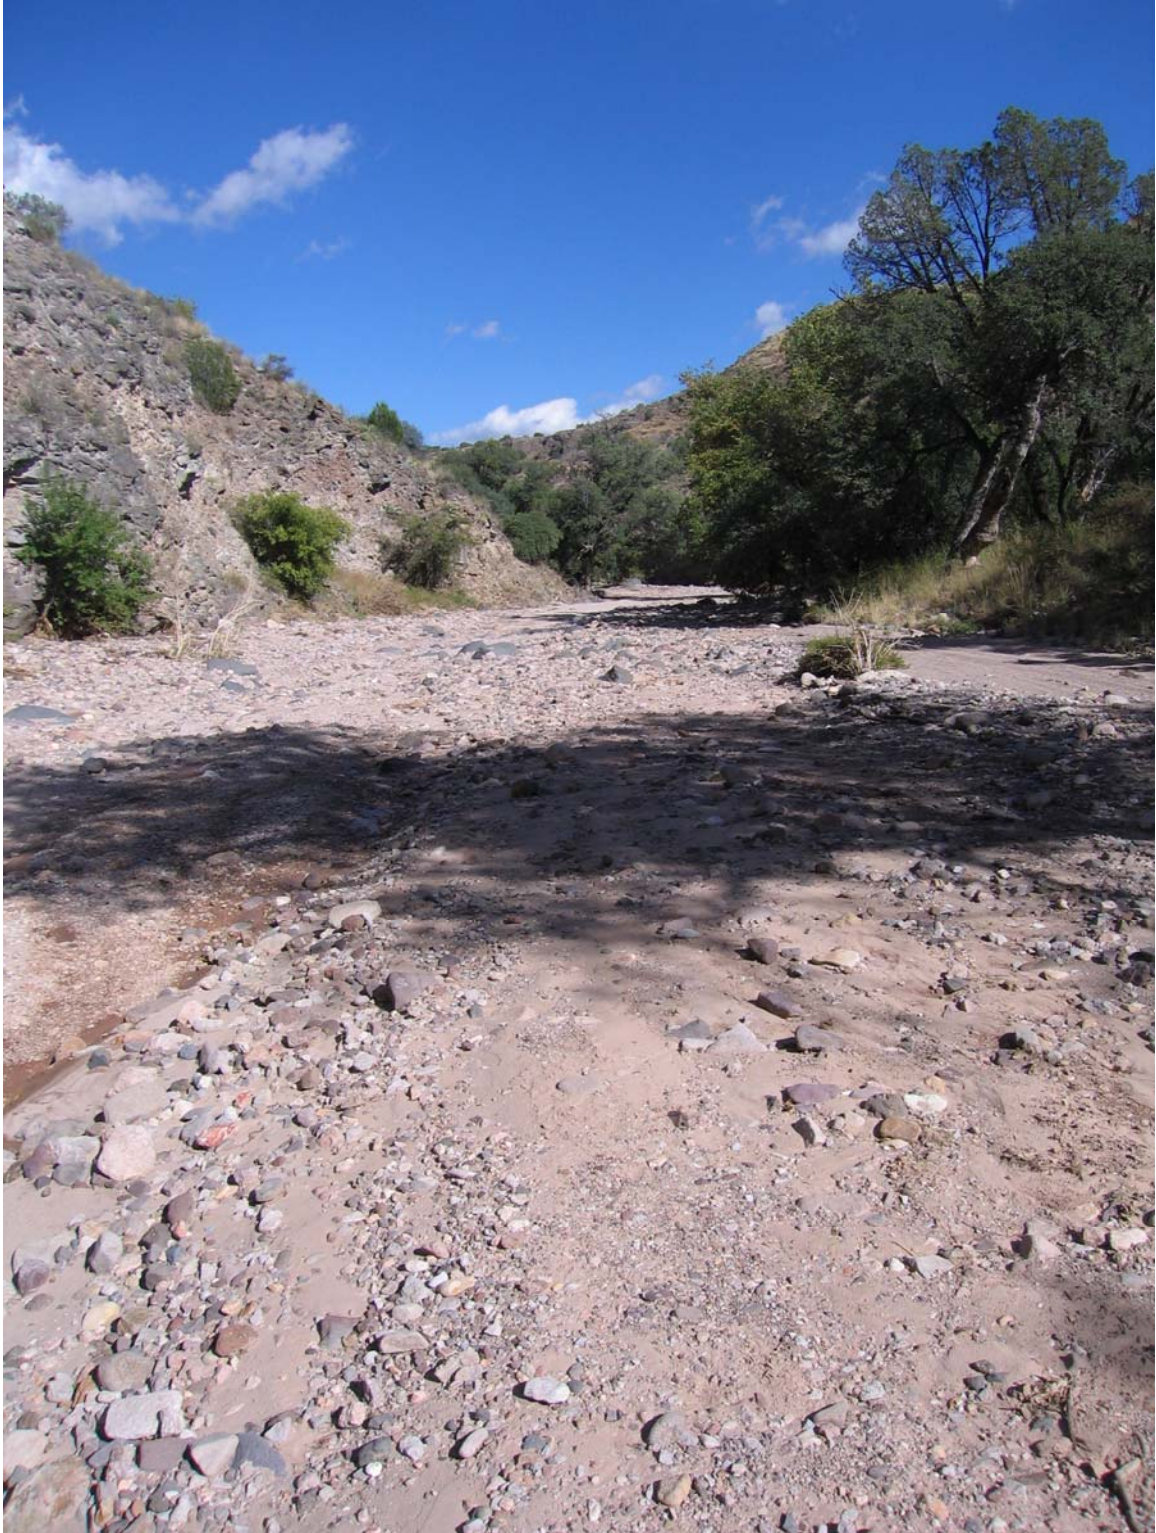
Photo 9. 12S 0698246//UTM 3676274 –Motor vehicle tracks into river as Big Dry Creek travels toward the San Francisco River.

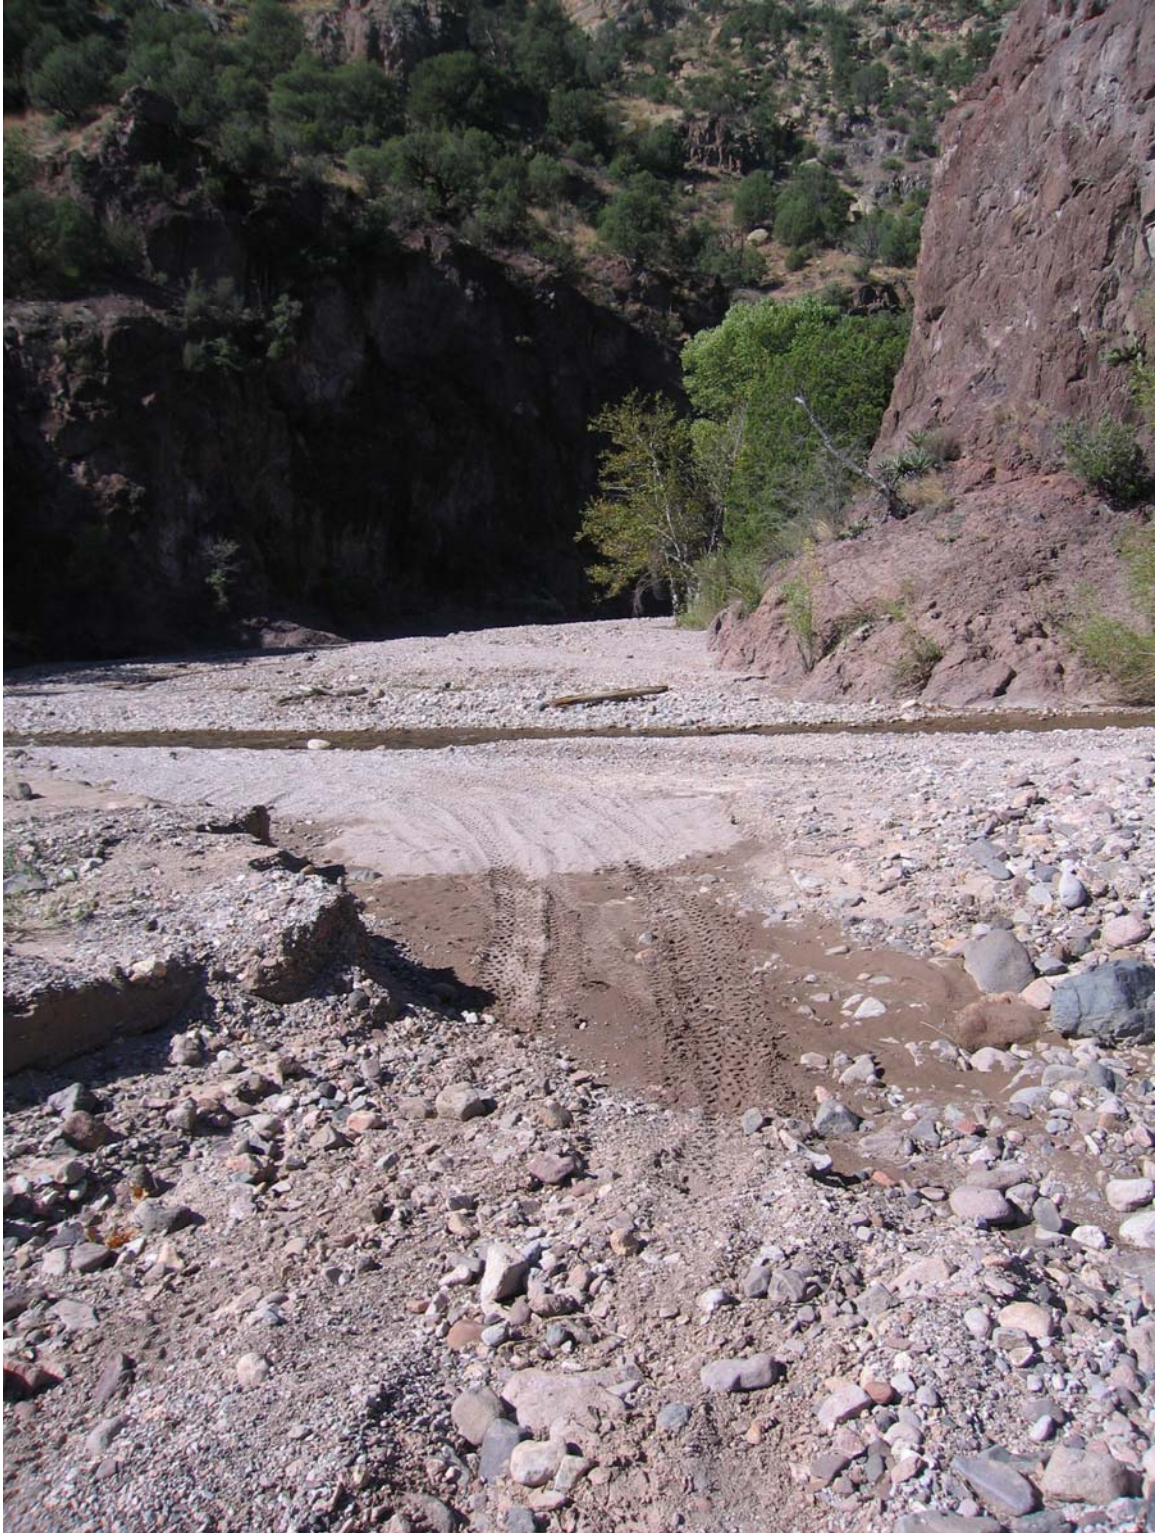
Photo 10. 12S 0698246//UTM 3676274 – Multiple tracks into creek causing rutting and stirring up rocks.

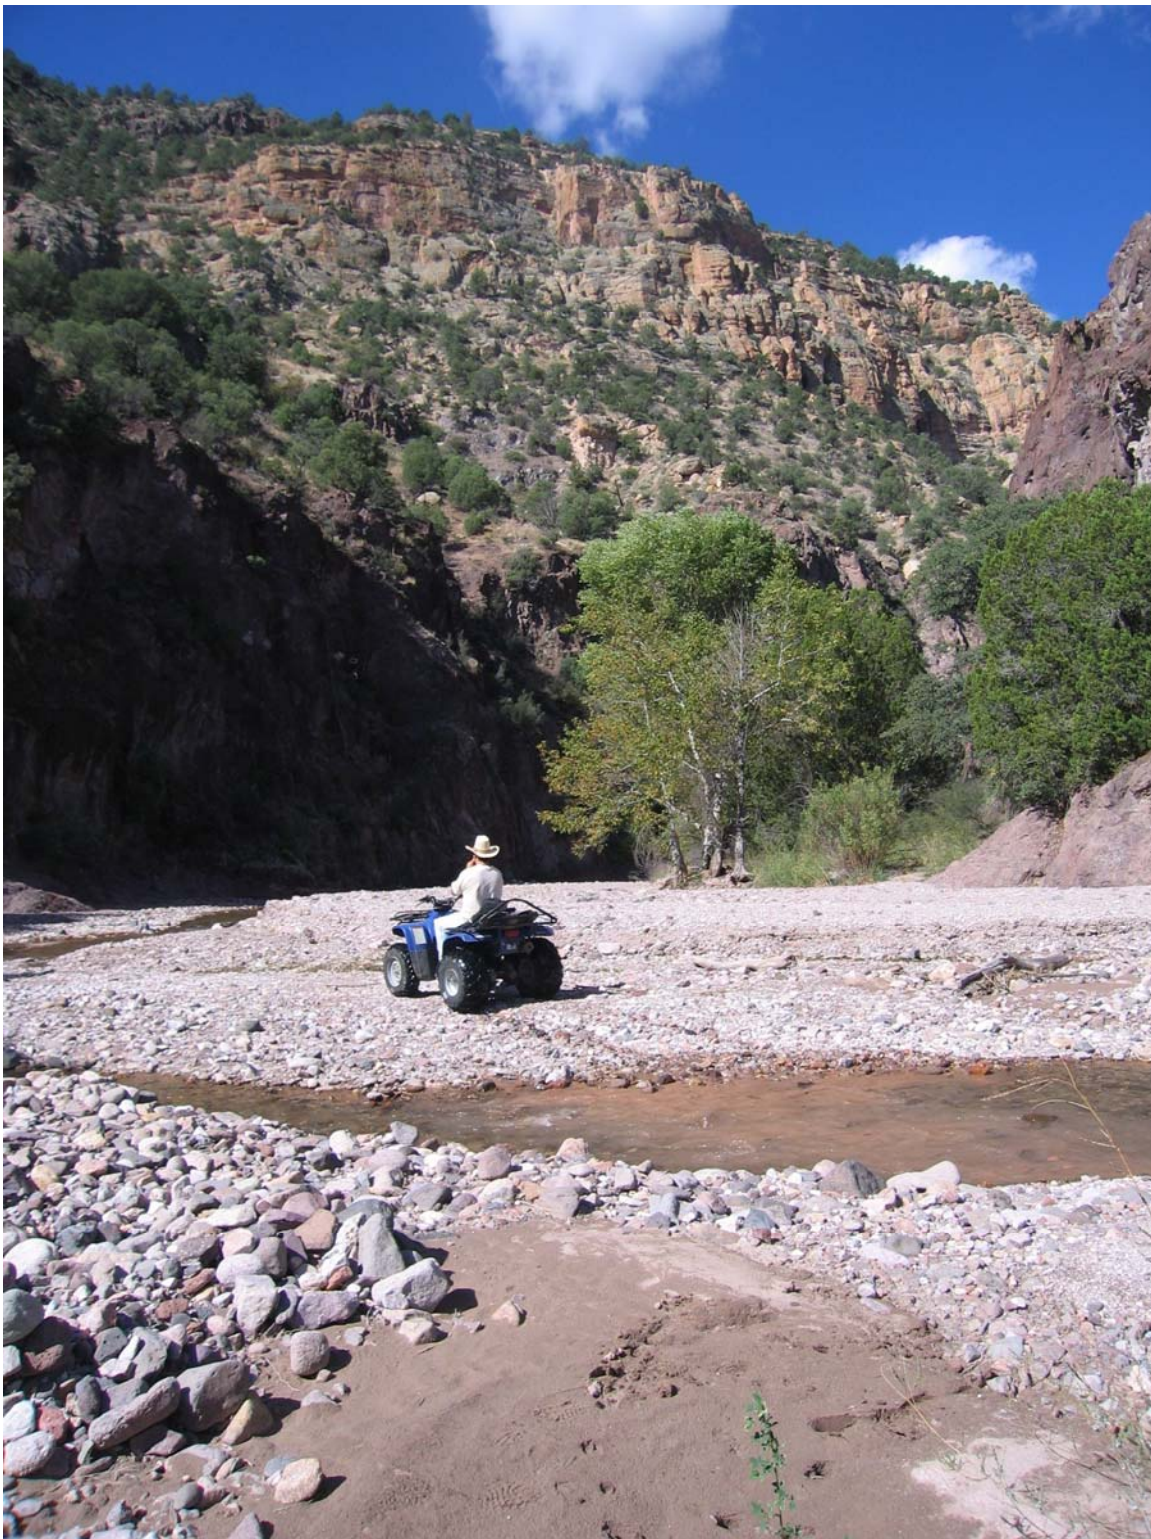
Photo 11. 12S 0698246//UTM 3676274 – Man on ATV after having driven down and in the creek for a ½ mile or more.

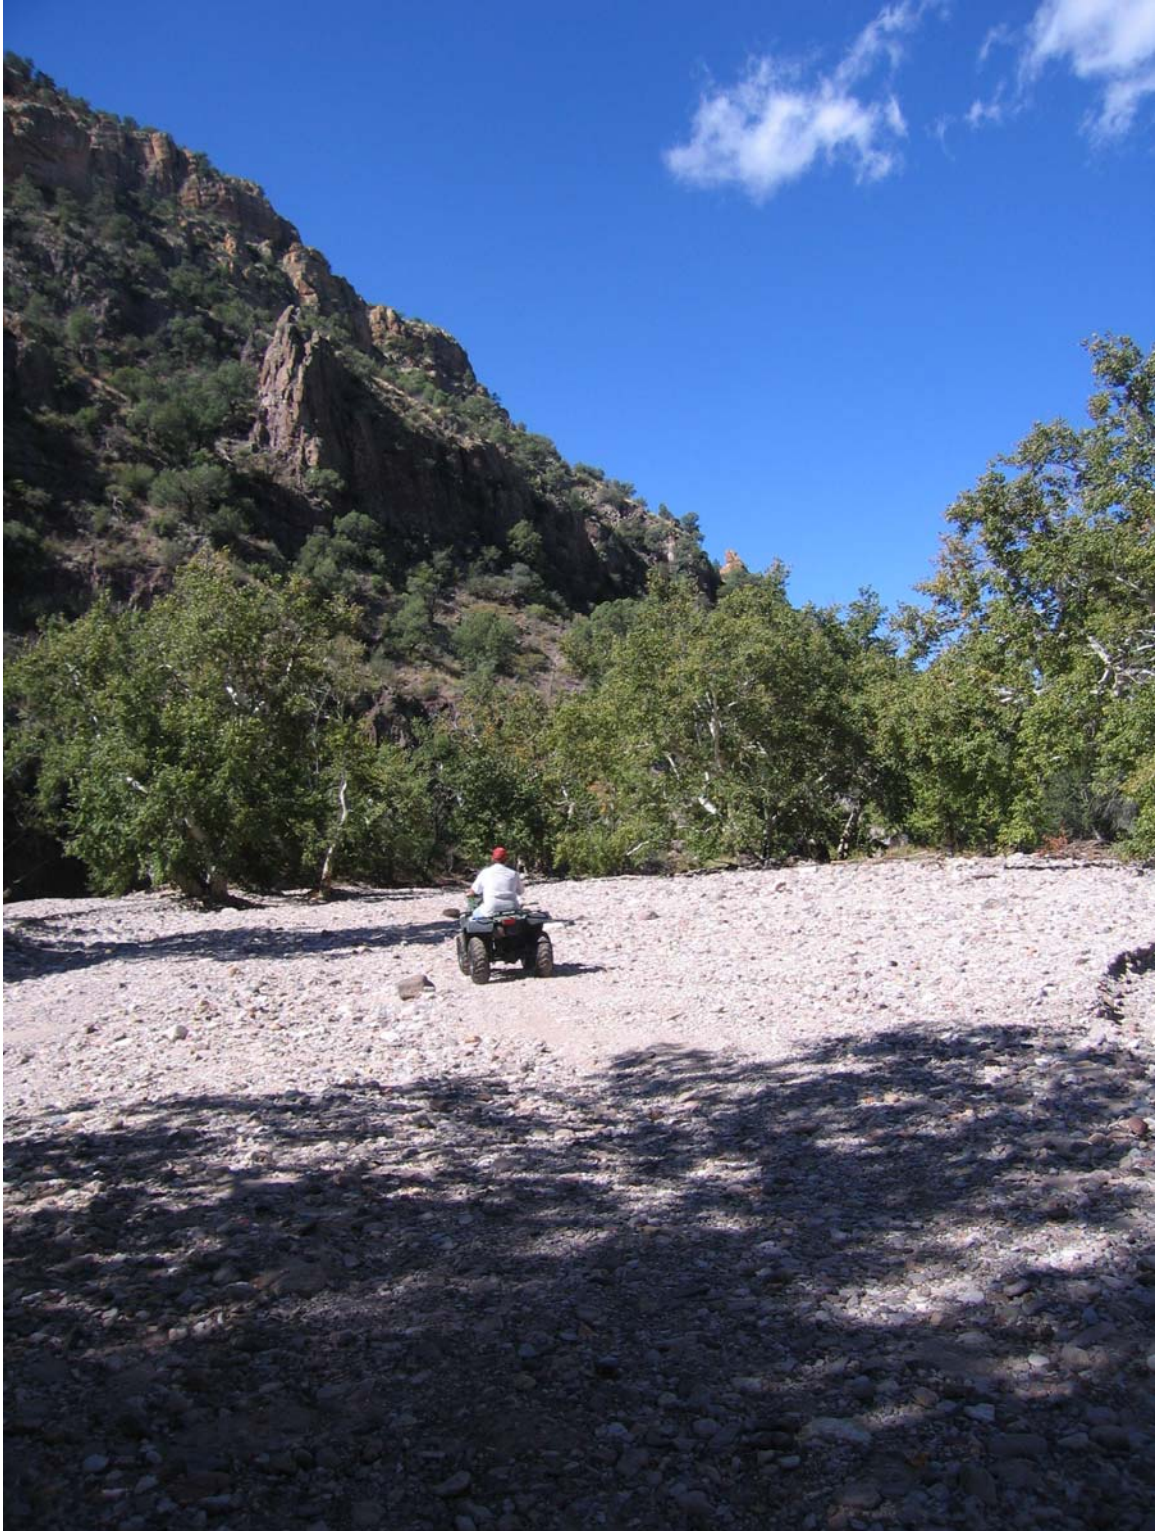
Photo 12. 12S 0697915//UTM 3676703 –Area rancher on ATV heading down the creek bed. Explained that he was looking for 10 to 15 of his cattle that had been on the river for about a week. This area is closed to grazing.

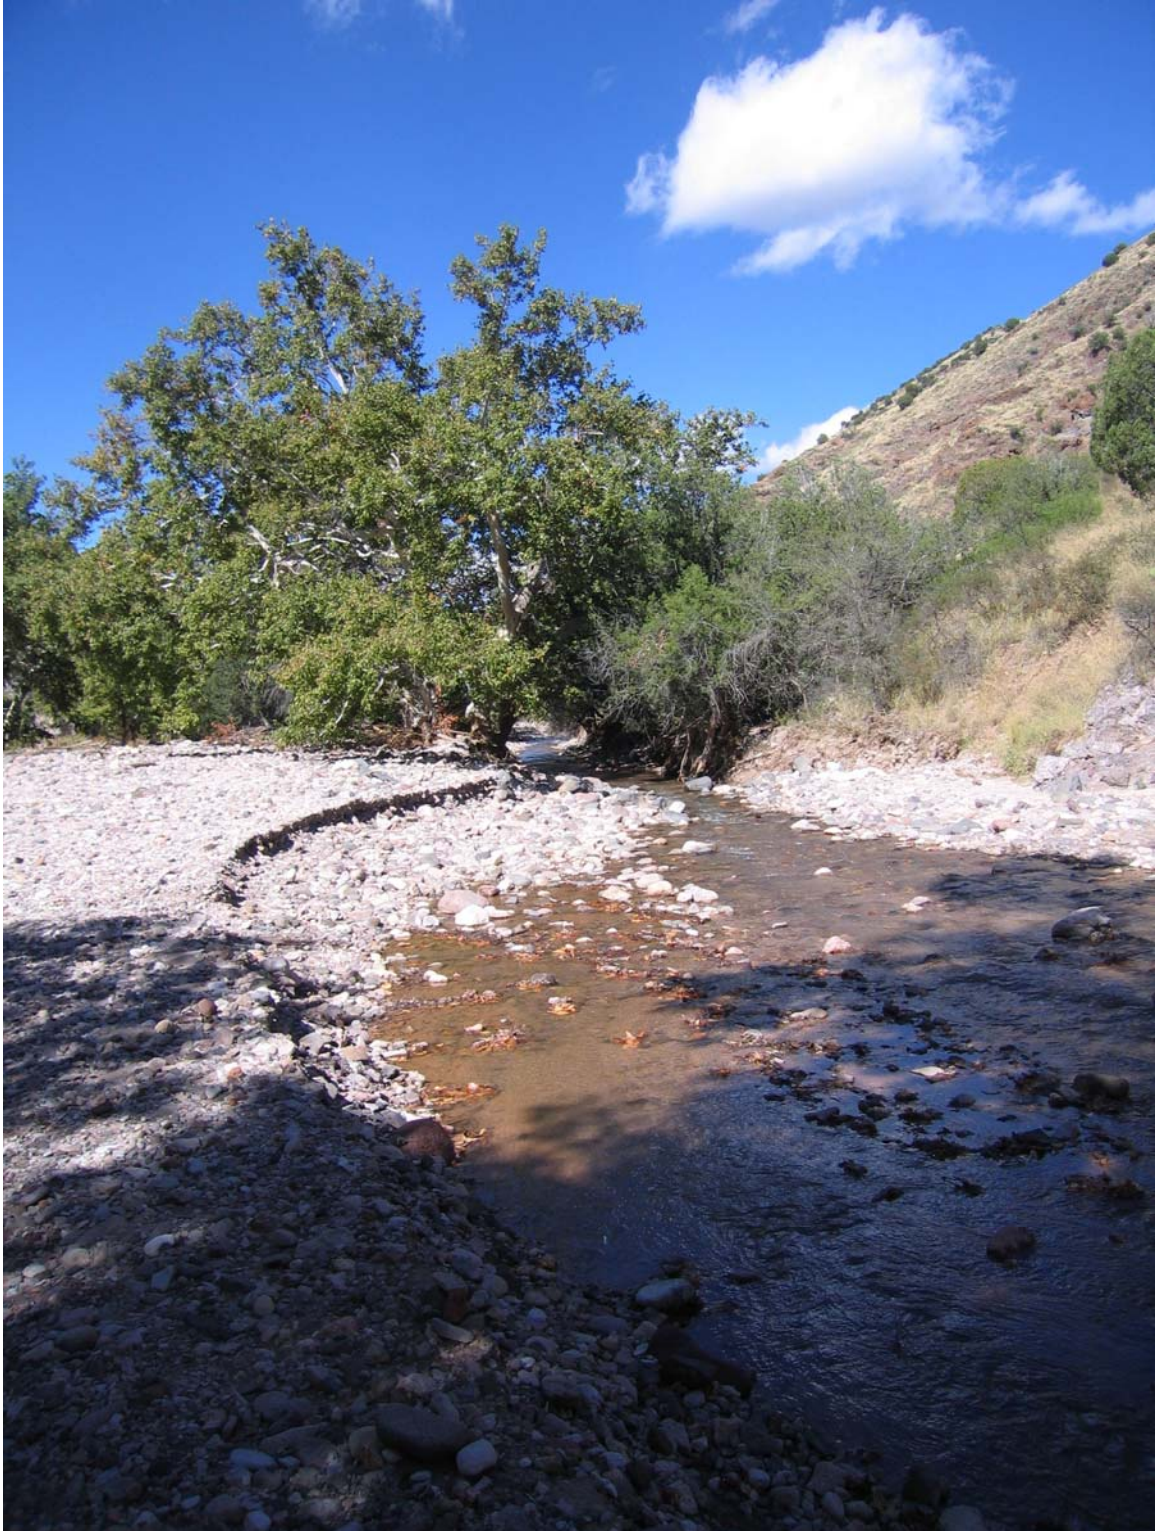
Photo 13. 12S 0697915//UTM 3676703 – Route travels parallel and then into creek. Note cut banks of 2 to 4 feet and increased erosion and sedimentation off of banks.

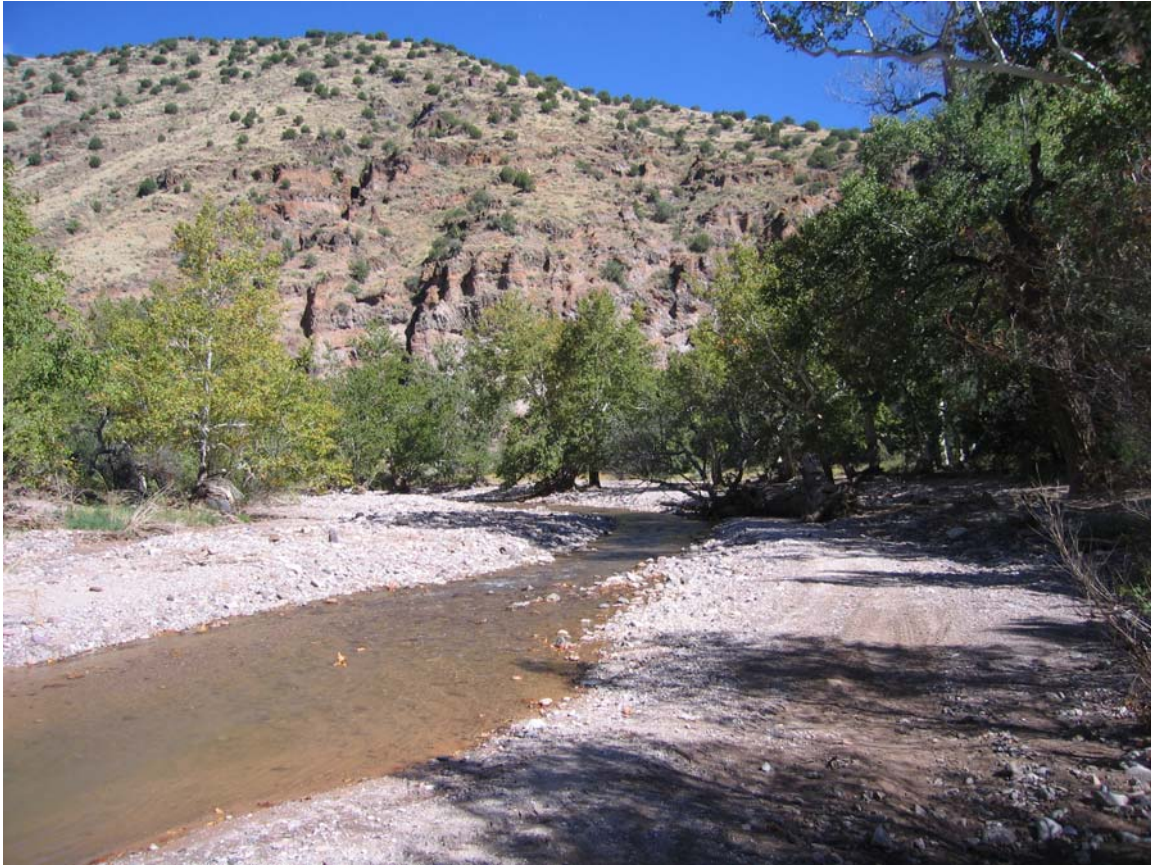
Photo 14. 12S 0698022//UTM 3676580 – Beautiful scenery of the area and the creek. Note vehicle tracks paralleling and then entering the water.
