Appendix A: San Francisco River Photos – Gila National Forest

These photos accompany our request for closure to demonstrate both the outstanding ecological values associated with this area, as well as the ongoing damage due to ORV use in riparian areas. All photos were taken October 6 or 7, 2007 by Chris Kassar and all GPS points were taken using NAD 27 Datum. The photo point numbers match up with the red triangles found on the associated map of the area (Appendix C: Map #3- Gila NF Photo Points).

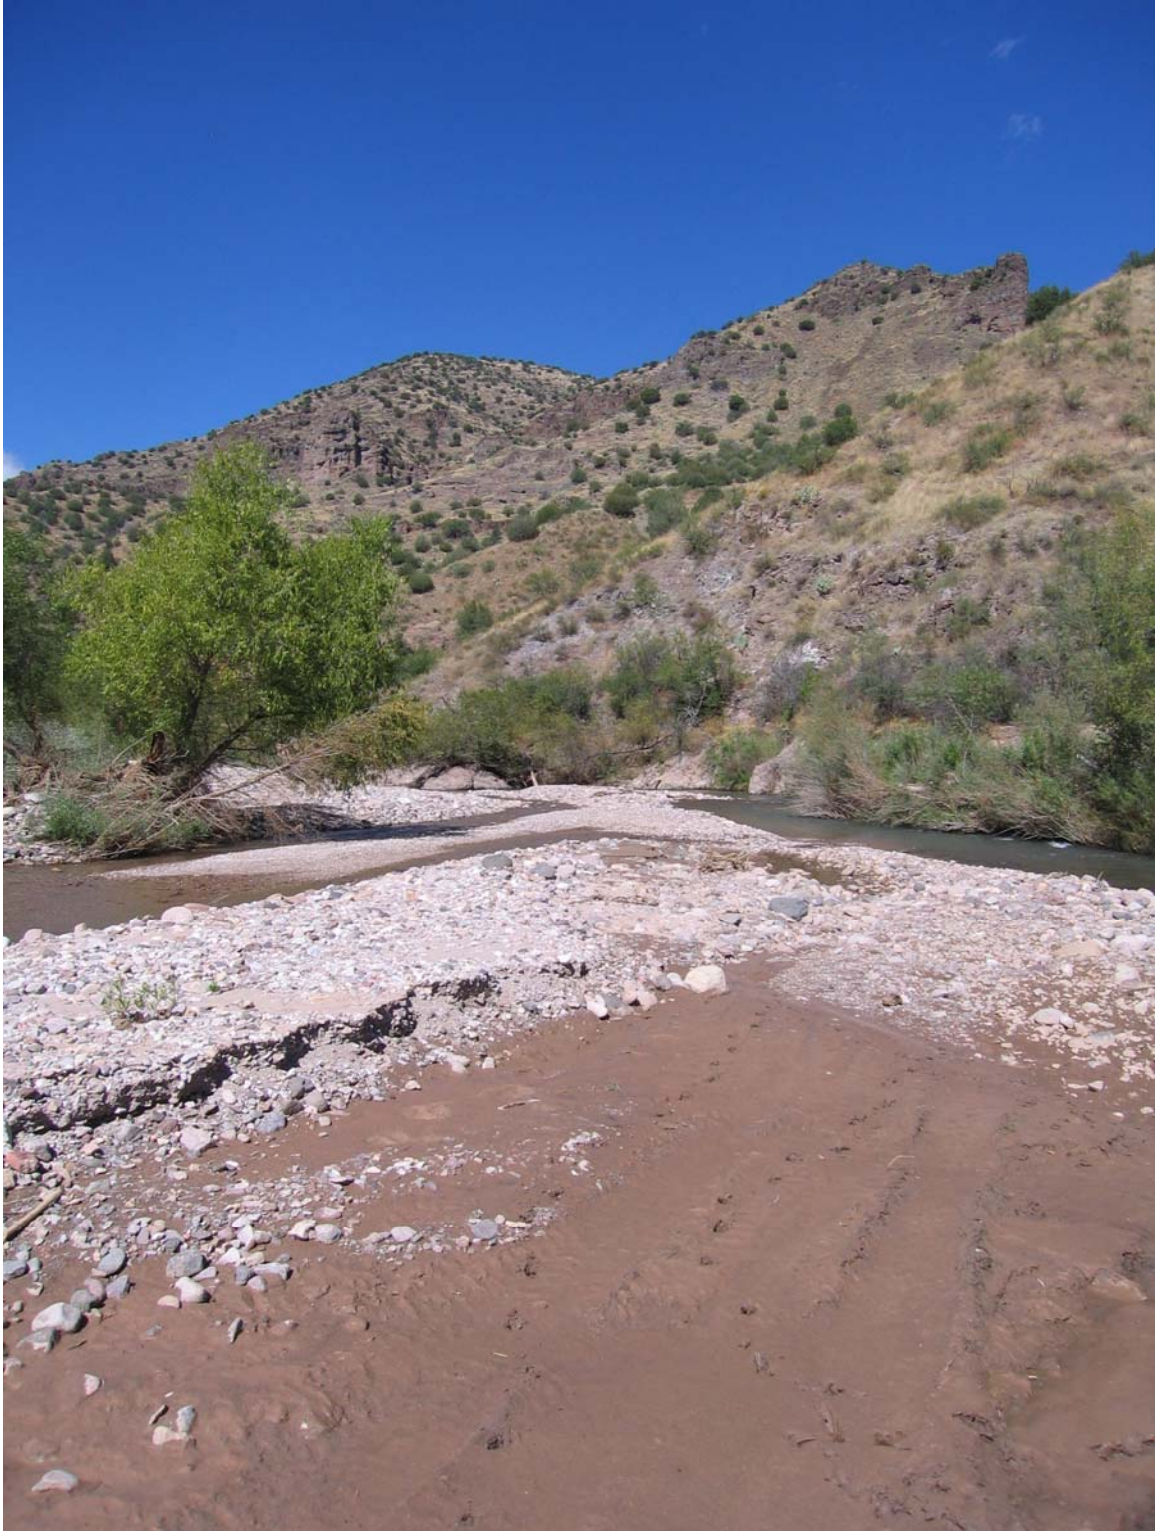
Photo 15. 12S 0696468//UTM 3677324 – Confluence of the San Francisco River (from North) and Big Dry Creek (from East). Evidence of people driving directly down the San Francisco River as well as parallel to it on the south side of the river.

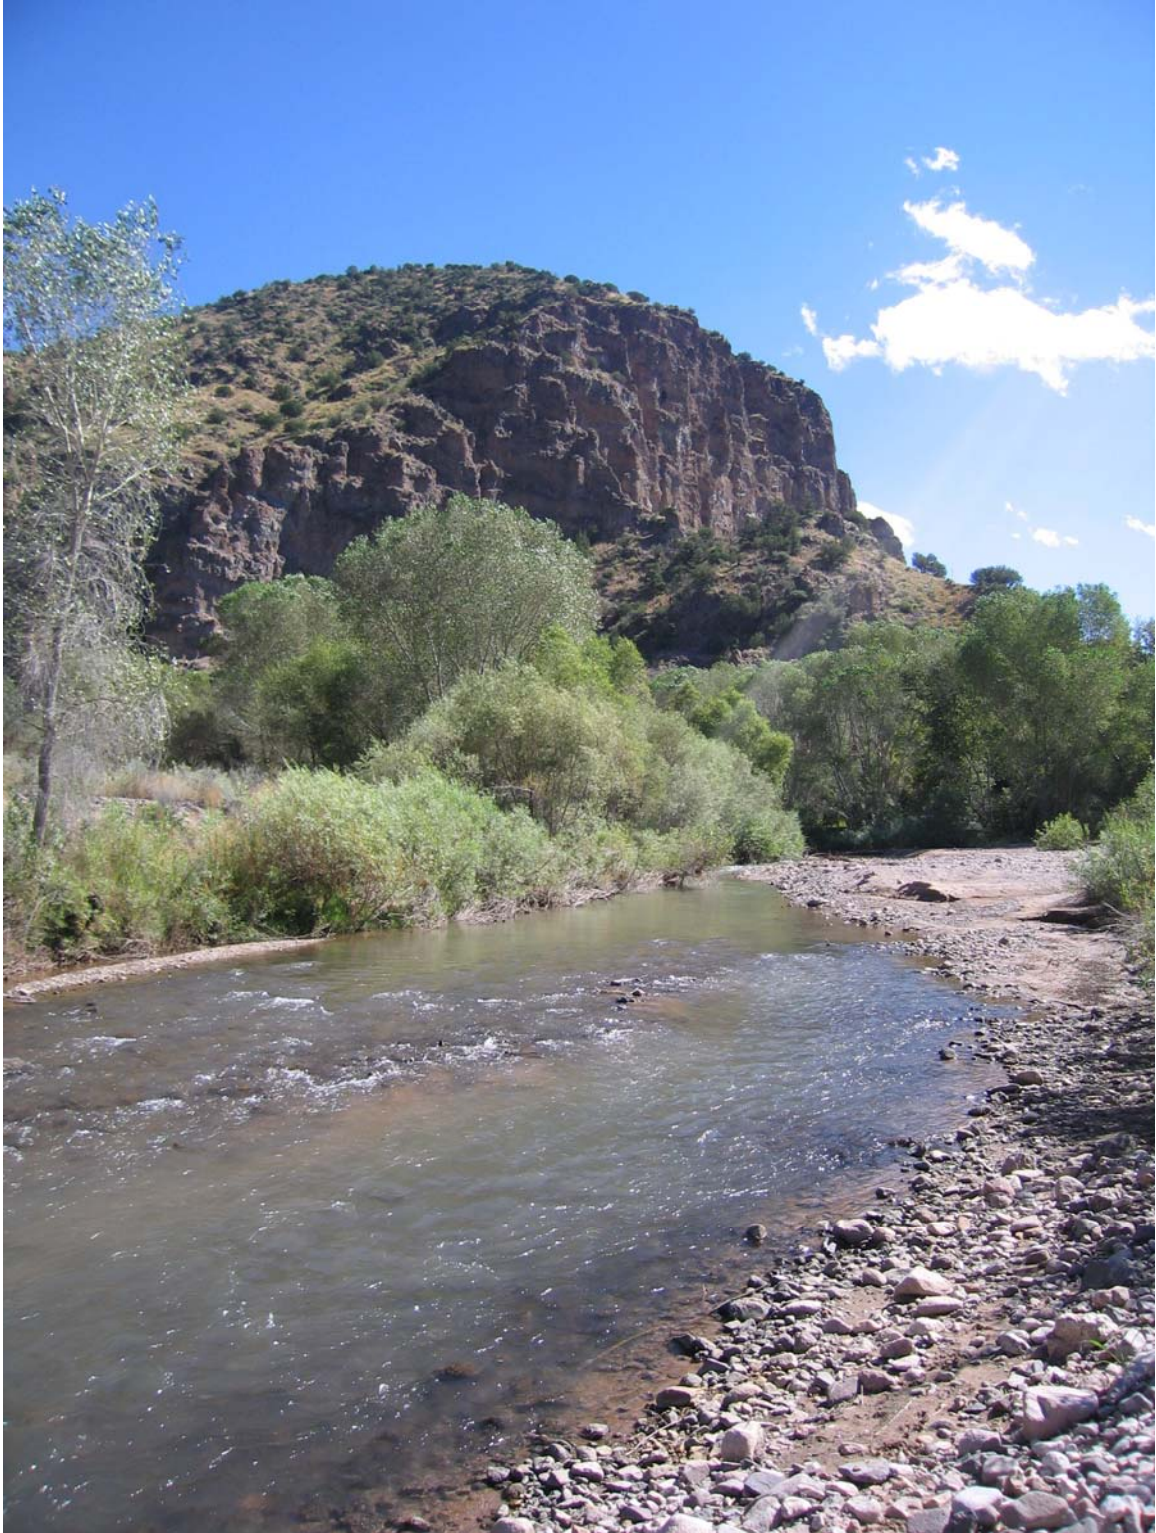
Photo 16. 12S 0696468//UTM 3677324 – San Francisco River below confluence with Big Dry Creek. Note riparian vegetation and tracks into and paralleling the river.

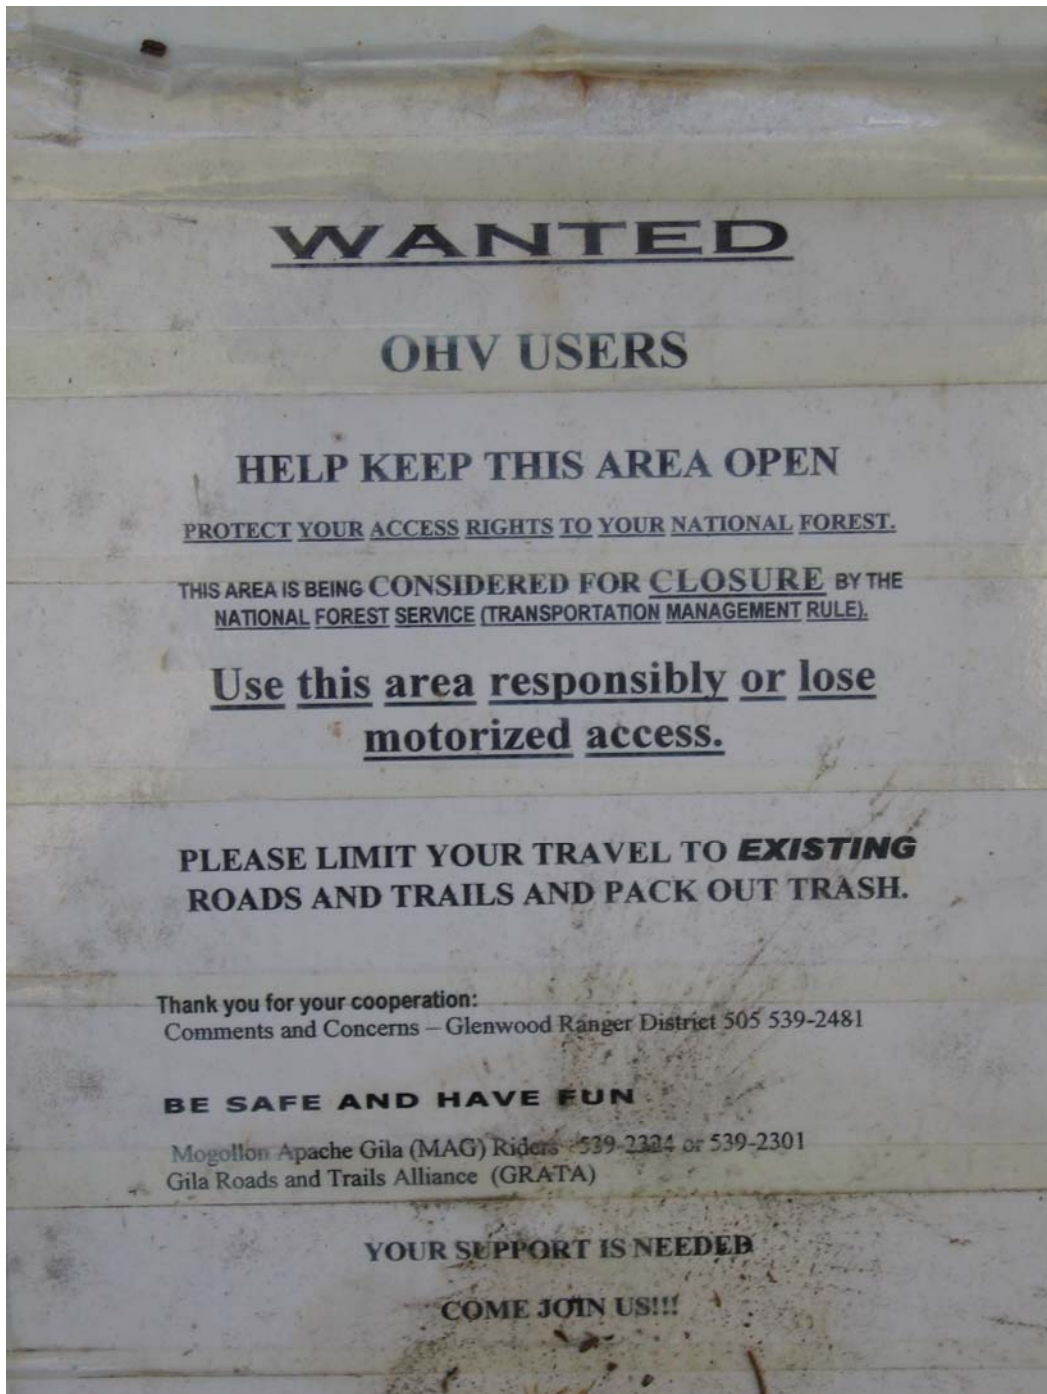
Photo 17. 12S 0696175//UTM 3677337 – Sign posted on fence next to river by off-road interests. Sign warns users that the area is being considered for closure by the Forest Service and warns of the potential for losing motorized access. It also asks riders to join their organizations (GRATA and the Mogollon Apache Gila Riders).

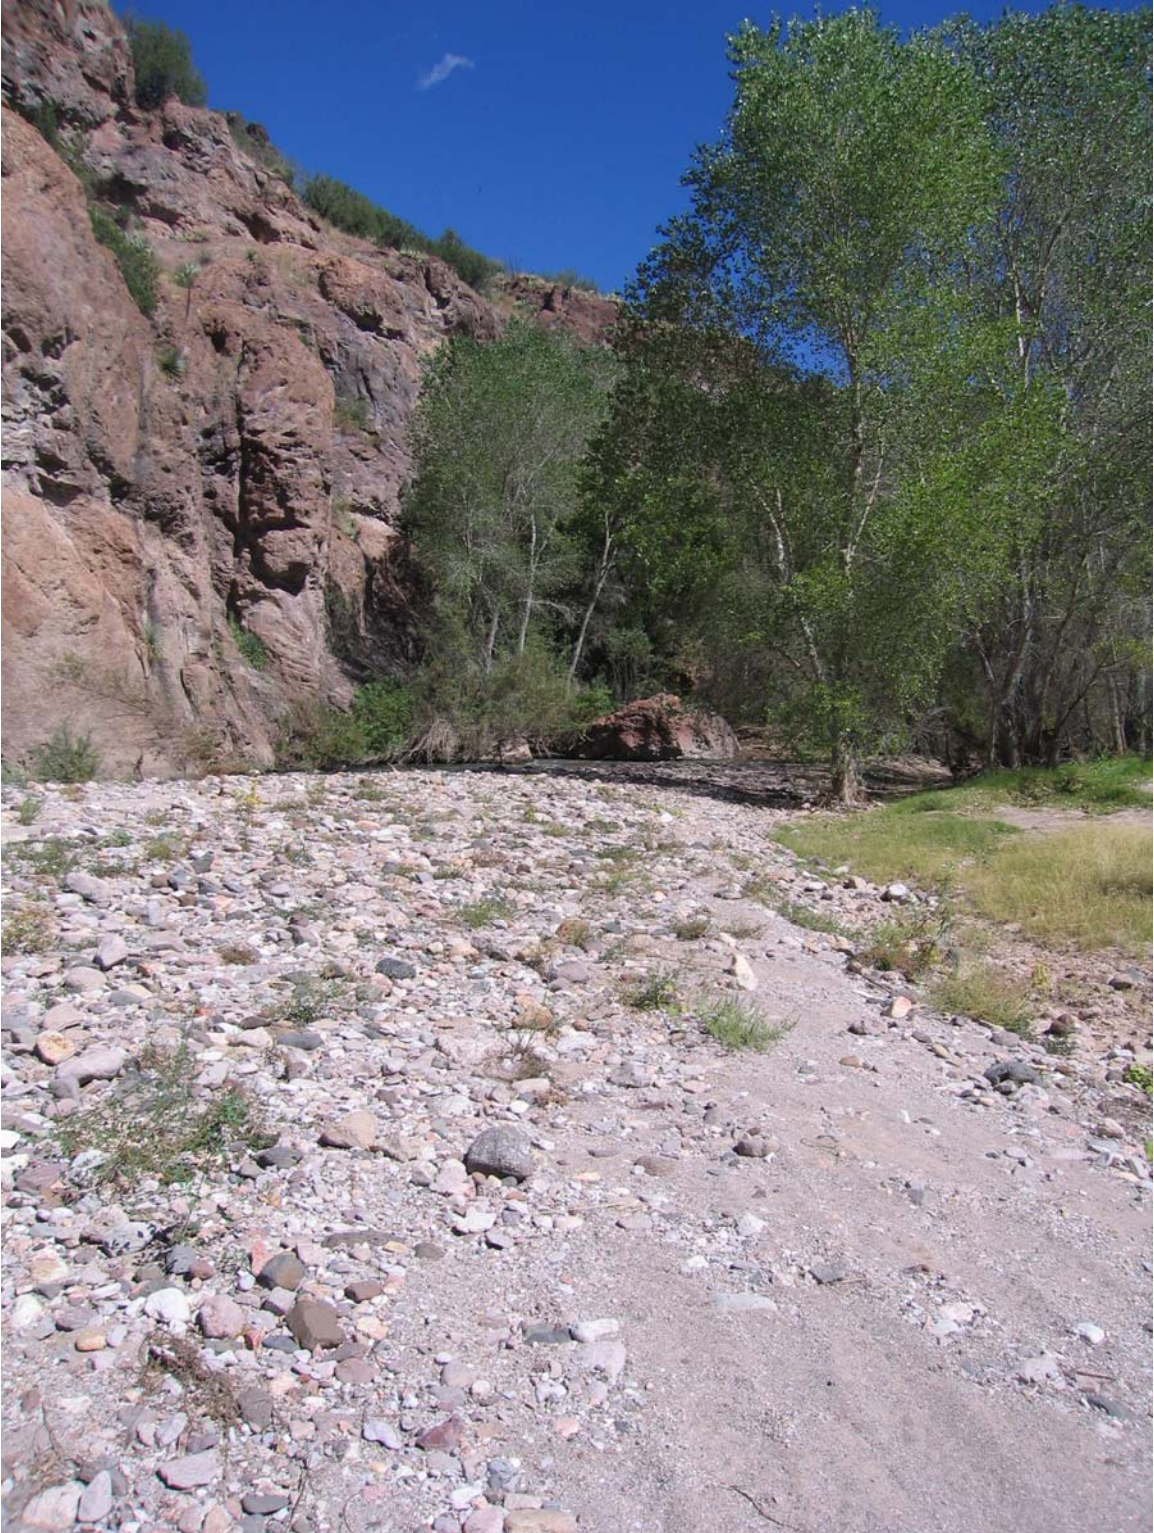
Photo 18. 12S 0696086//UTM 3677343– Off-road vehicle tracks continue into and down the river.

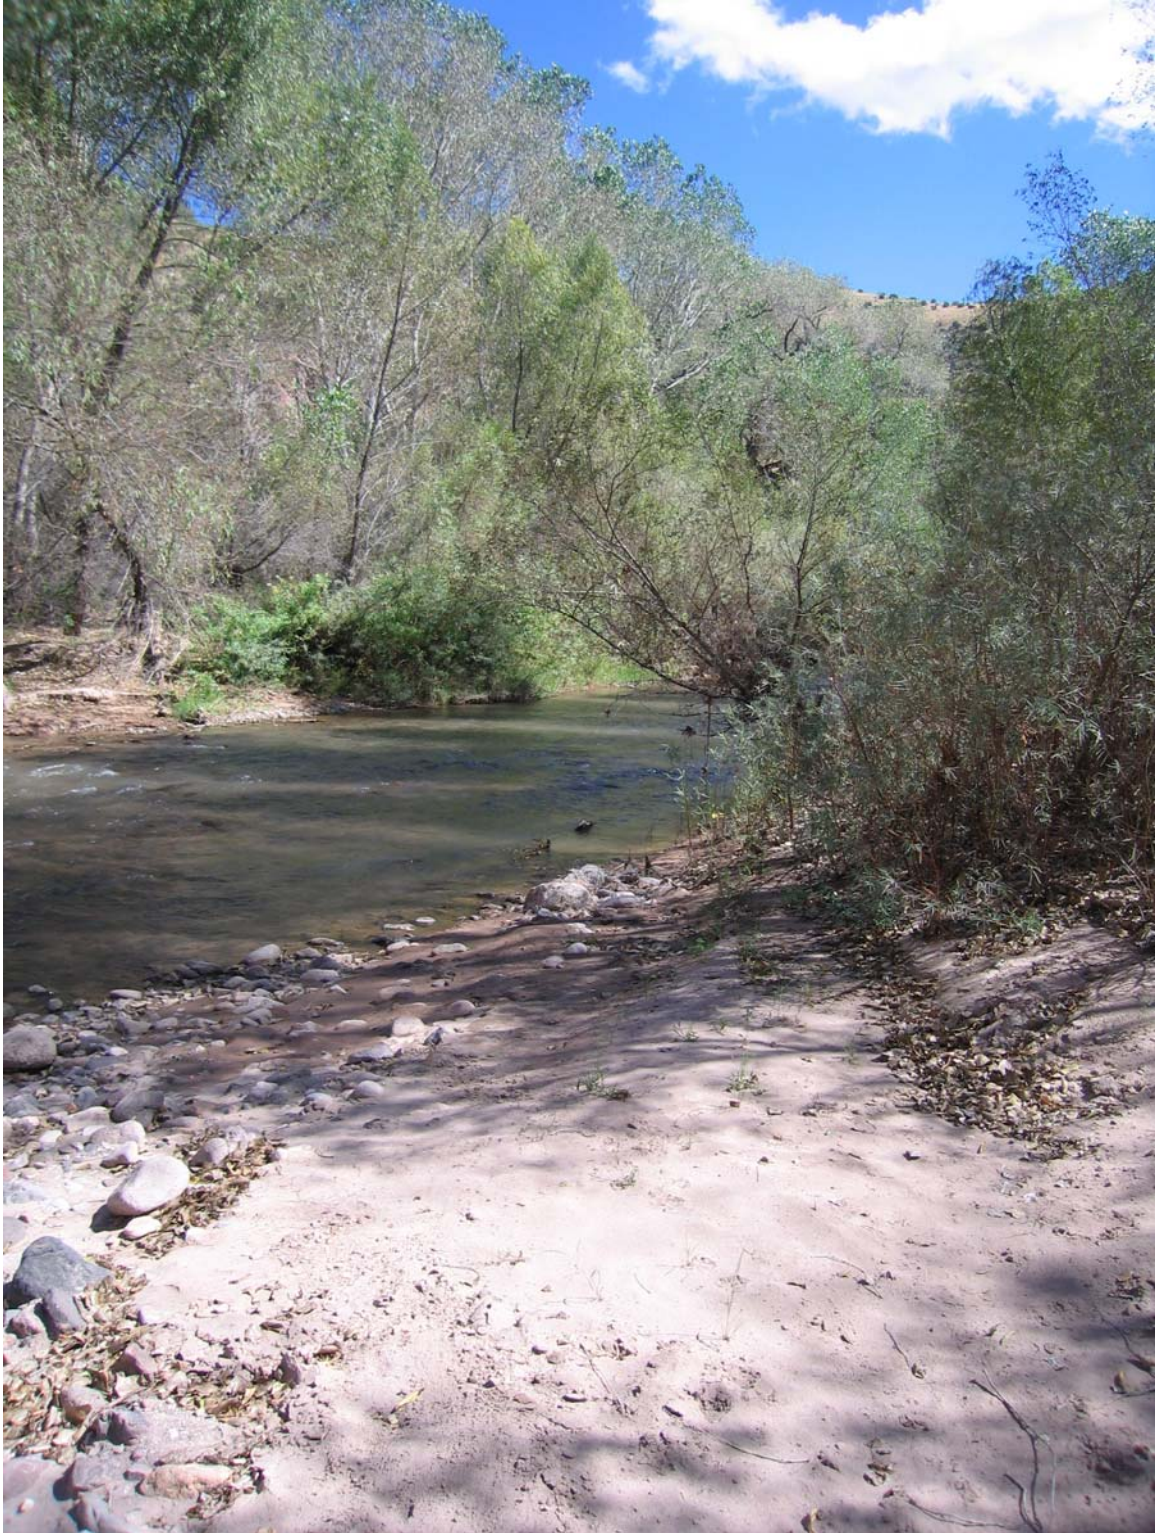
Photo 19. 12S 0696027//UTM 3677226– Tracks across the first large crossing of the San Francisco River. Significant amount of mud, bank cuts, obvious sedimentation and increased turbidity that could potentially negatively impact fish and other aquatic organisms.

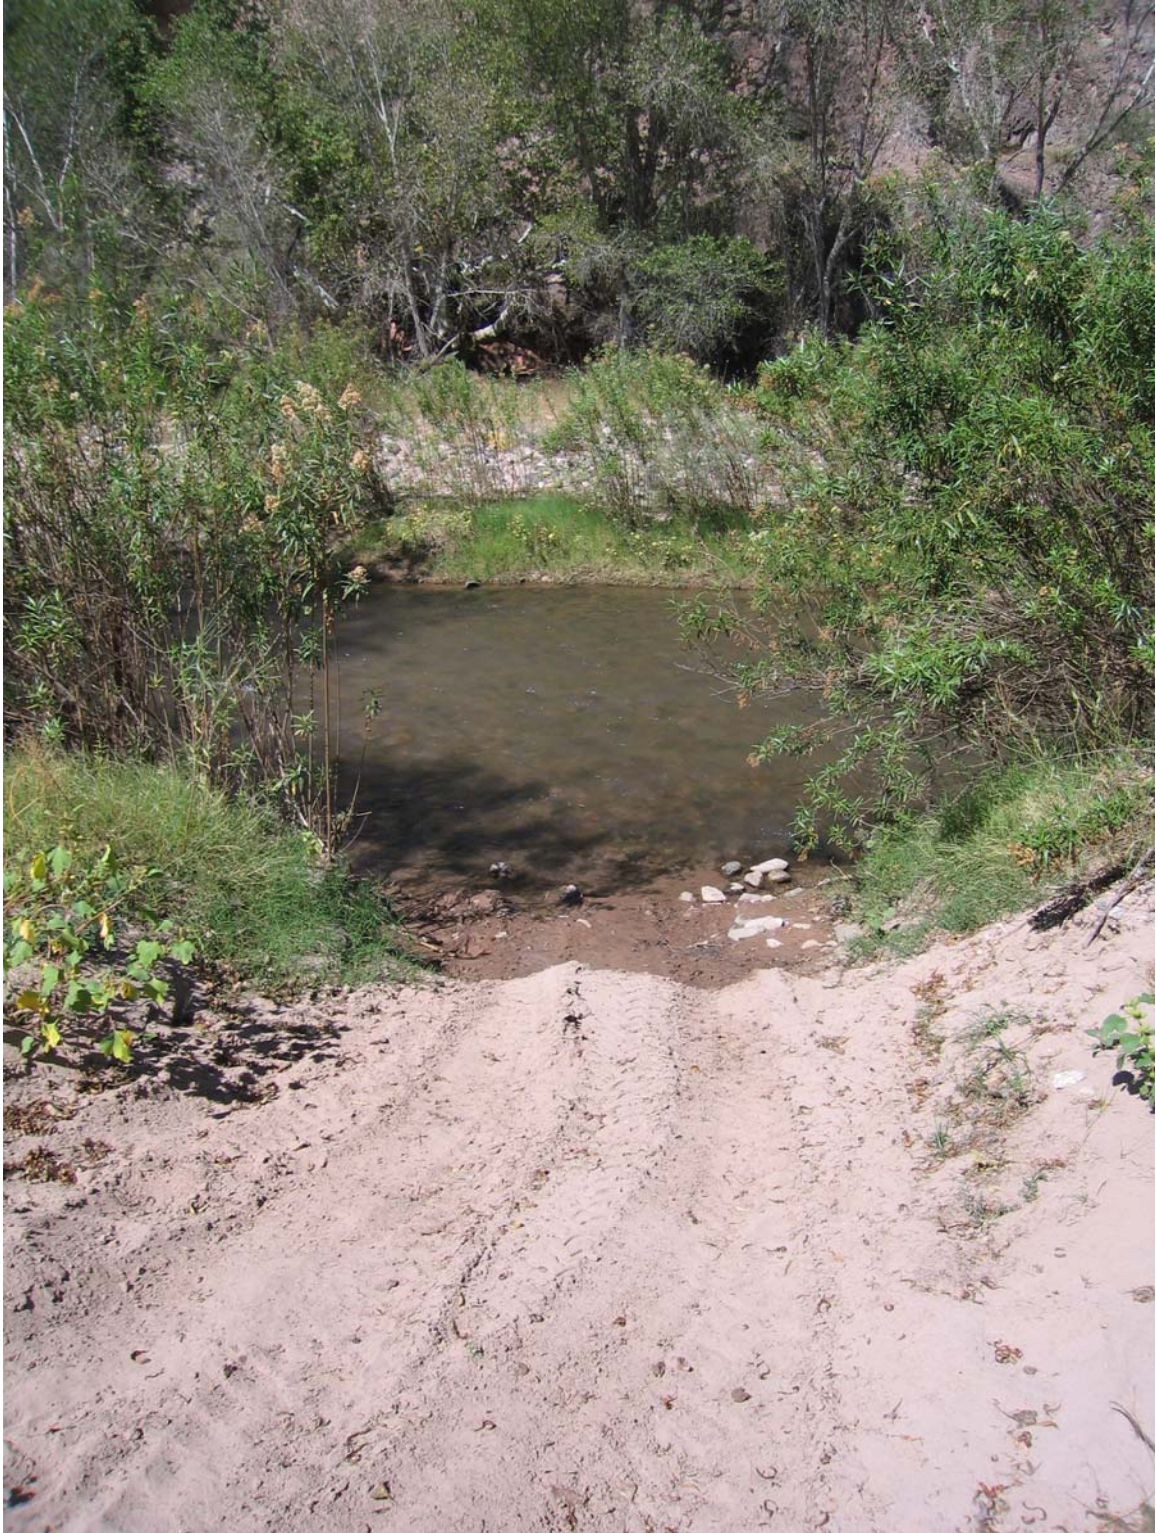
Photo 20. 12S 0696027//UTM 3677226 – Same as photo 19, different view.

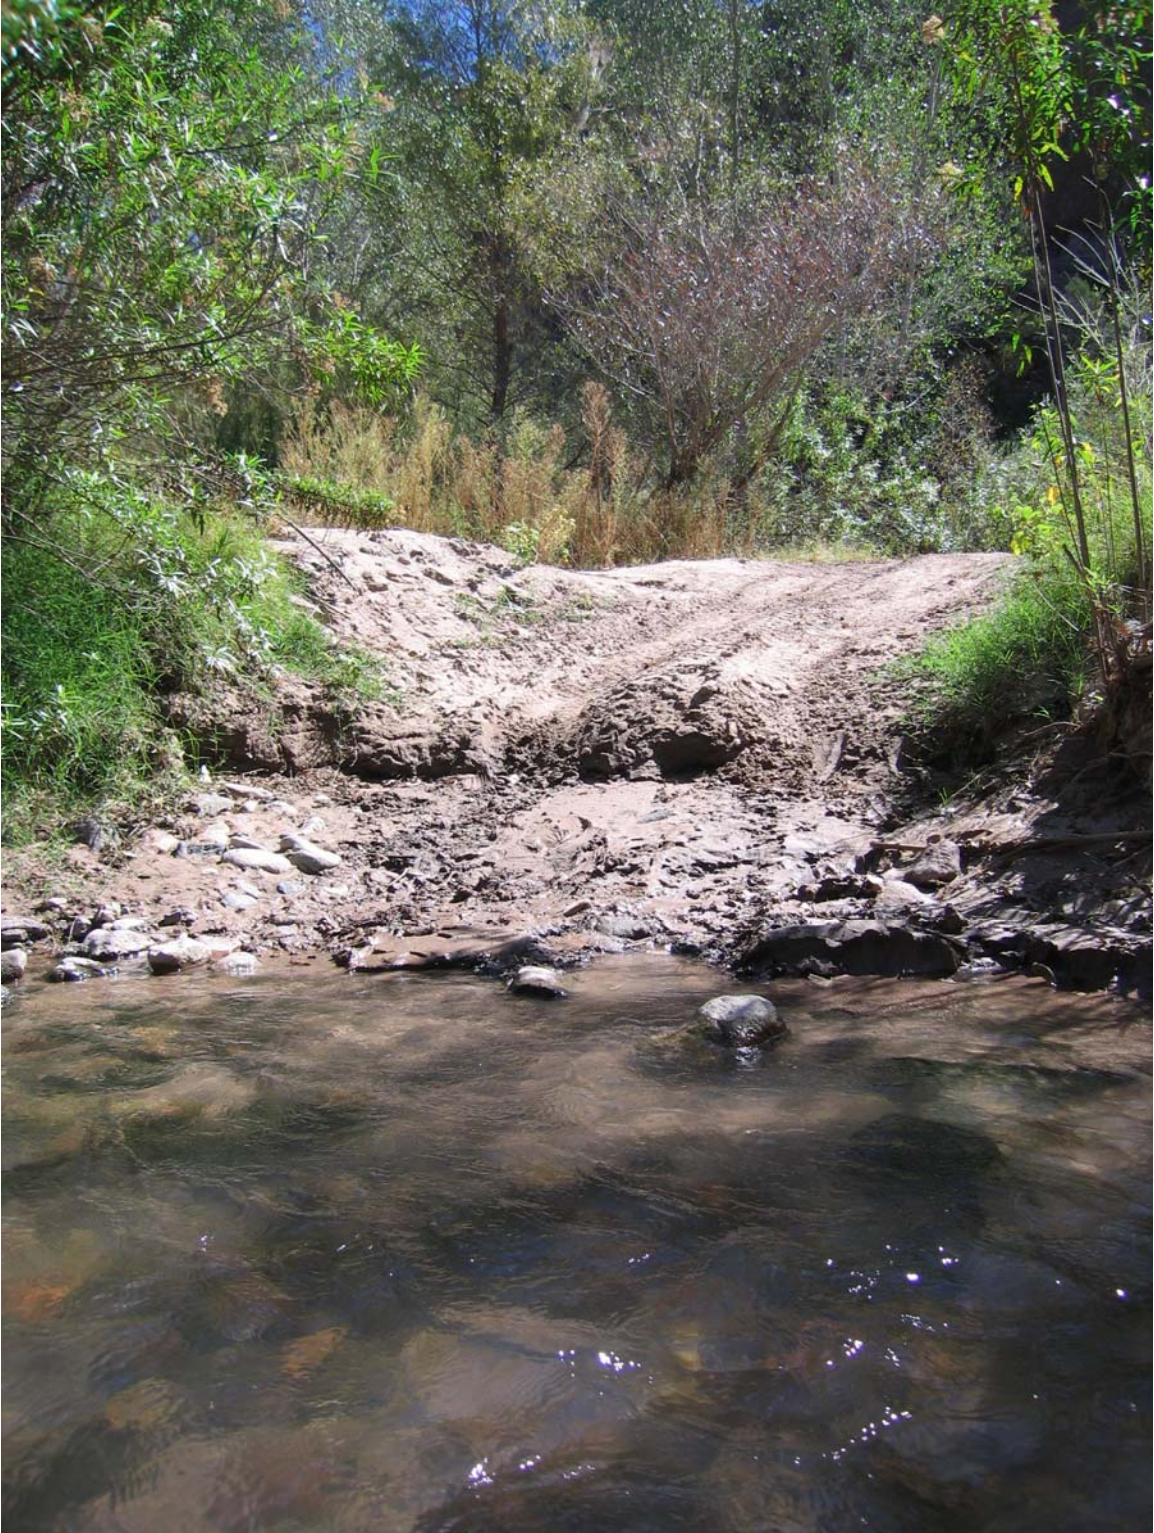
Photo 21. 12S 0696027//UTM 3677226 – Looking back at crossing described in photo 19 & 20. Note deep bank cuts (1 to 2 feet), erosion, unstable soil and increased turbidity.

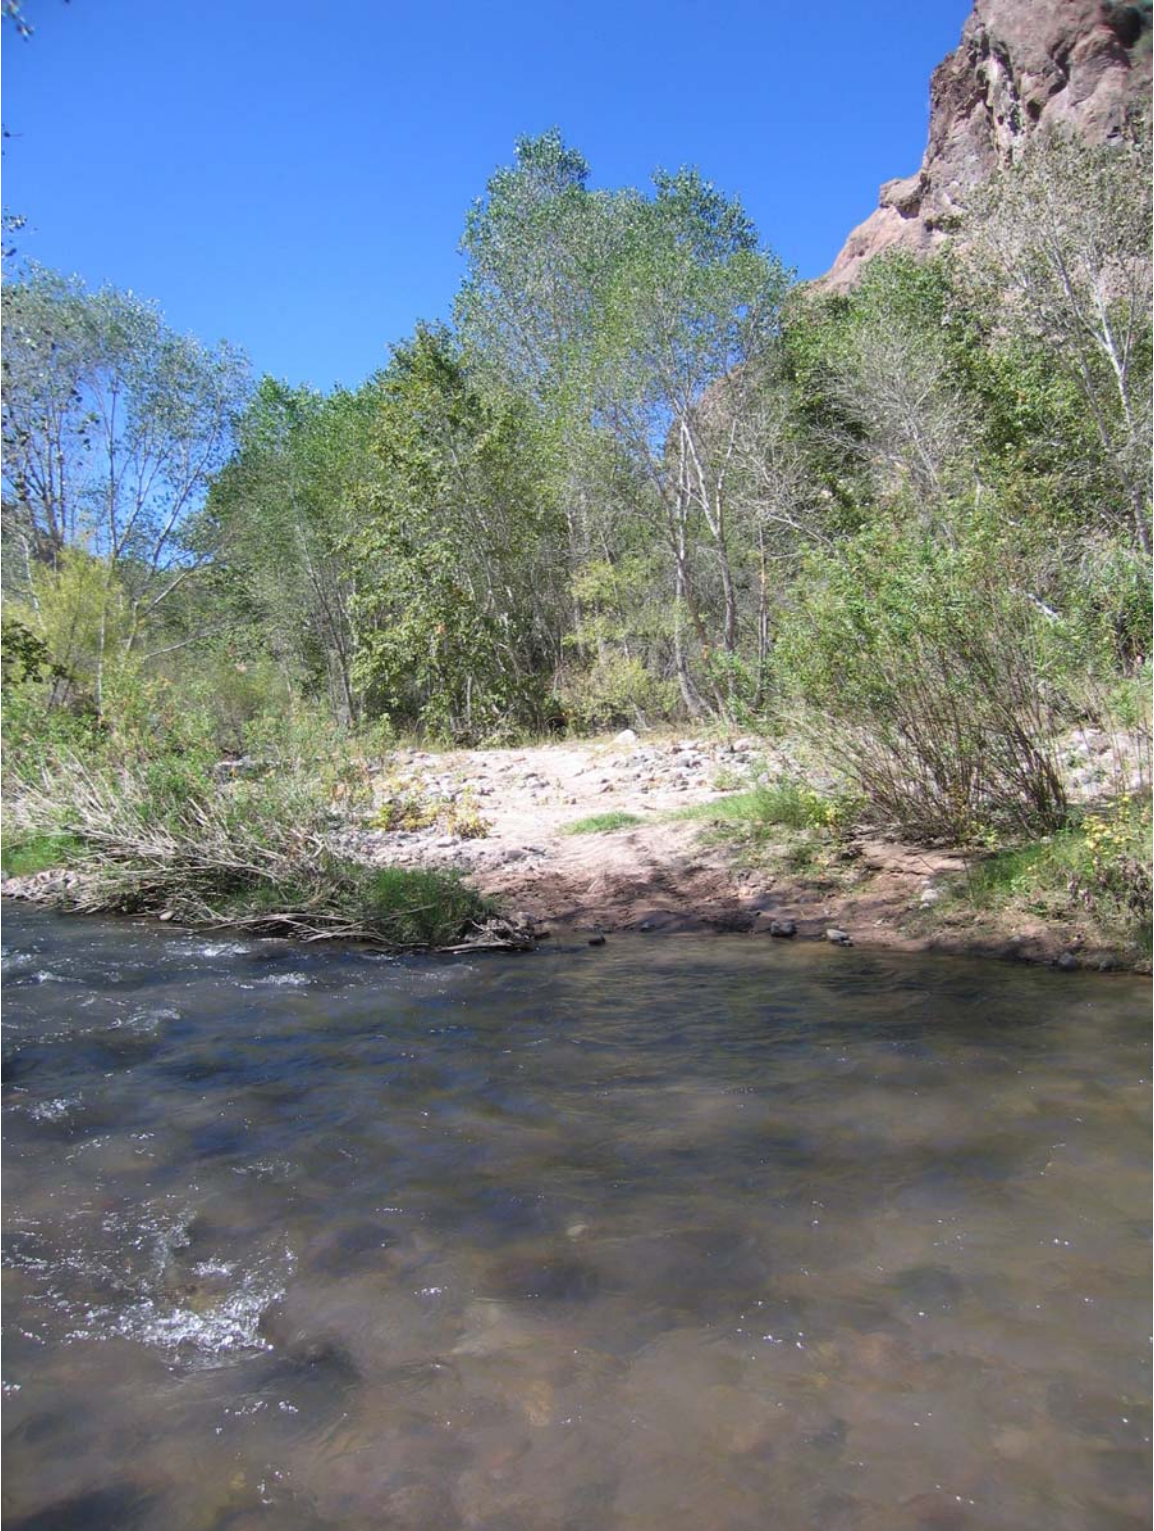
Photo 22. 12S 0695981//UTM 3677189 – Redundant crossing just downstream of previous crossing (Photos 19-21). Evidence of users continuing to drive down the river and to drive wherever they want on the banks of the river.

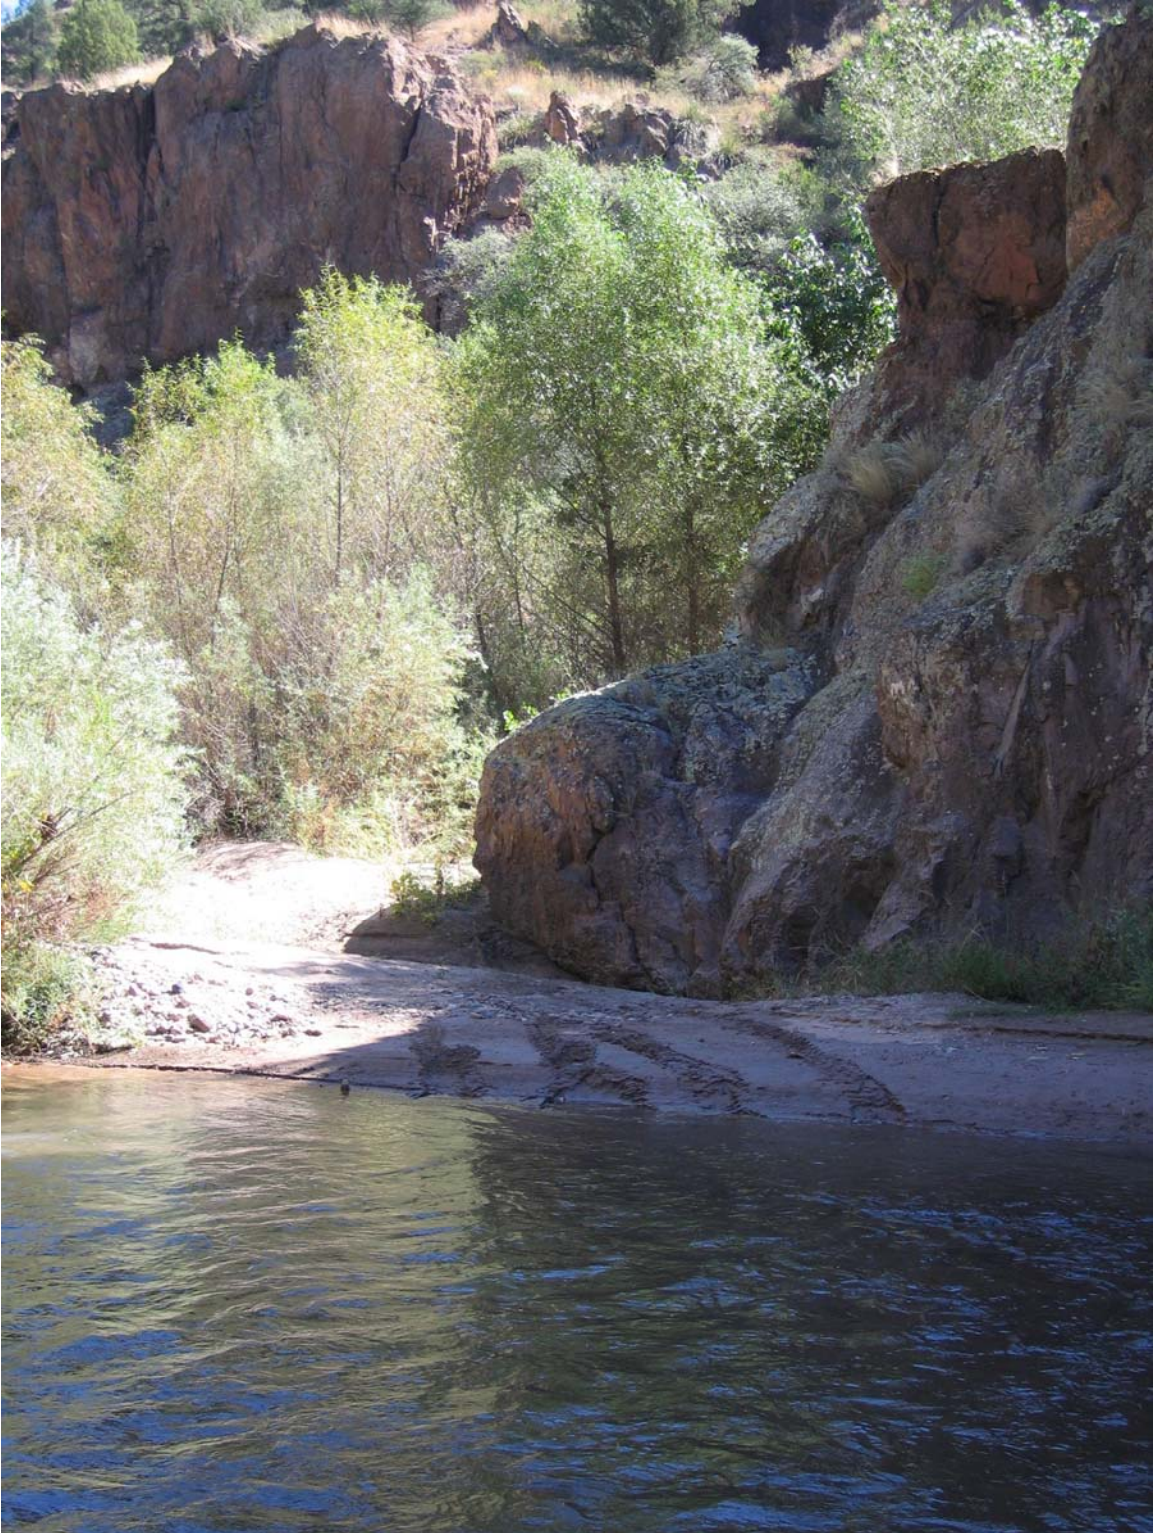
Photo 23. 12S 0695981//UTM 3677189 – Other side of crossing in Photo 22. Note evidence of recent use and bank cuts.

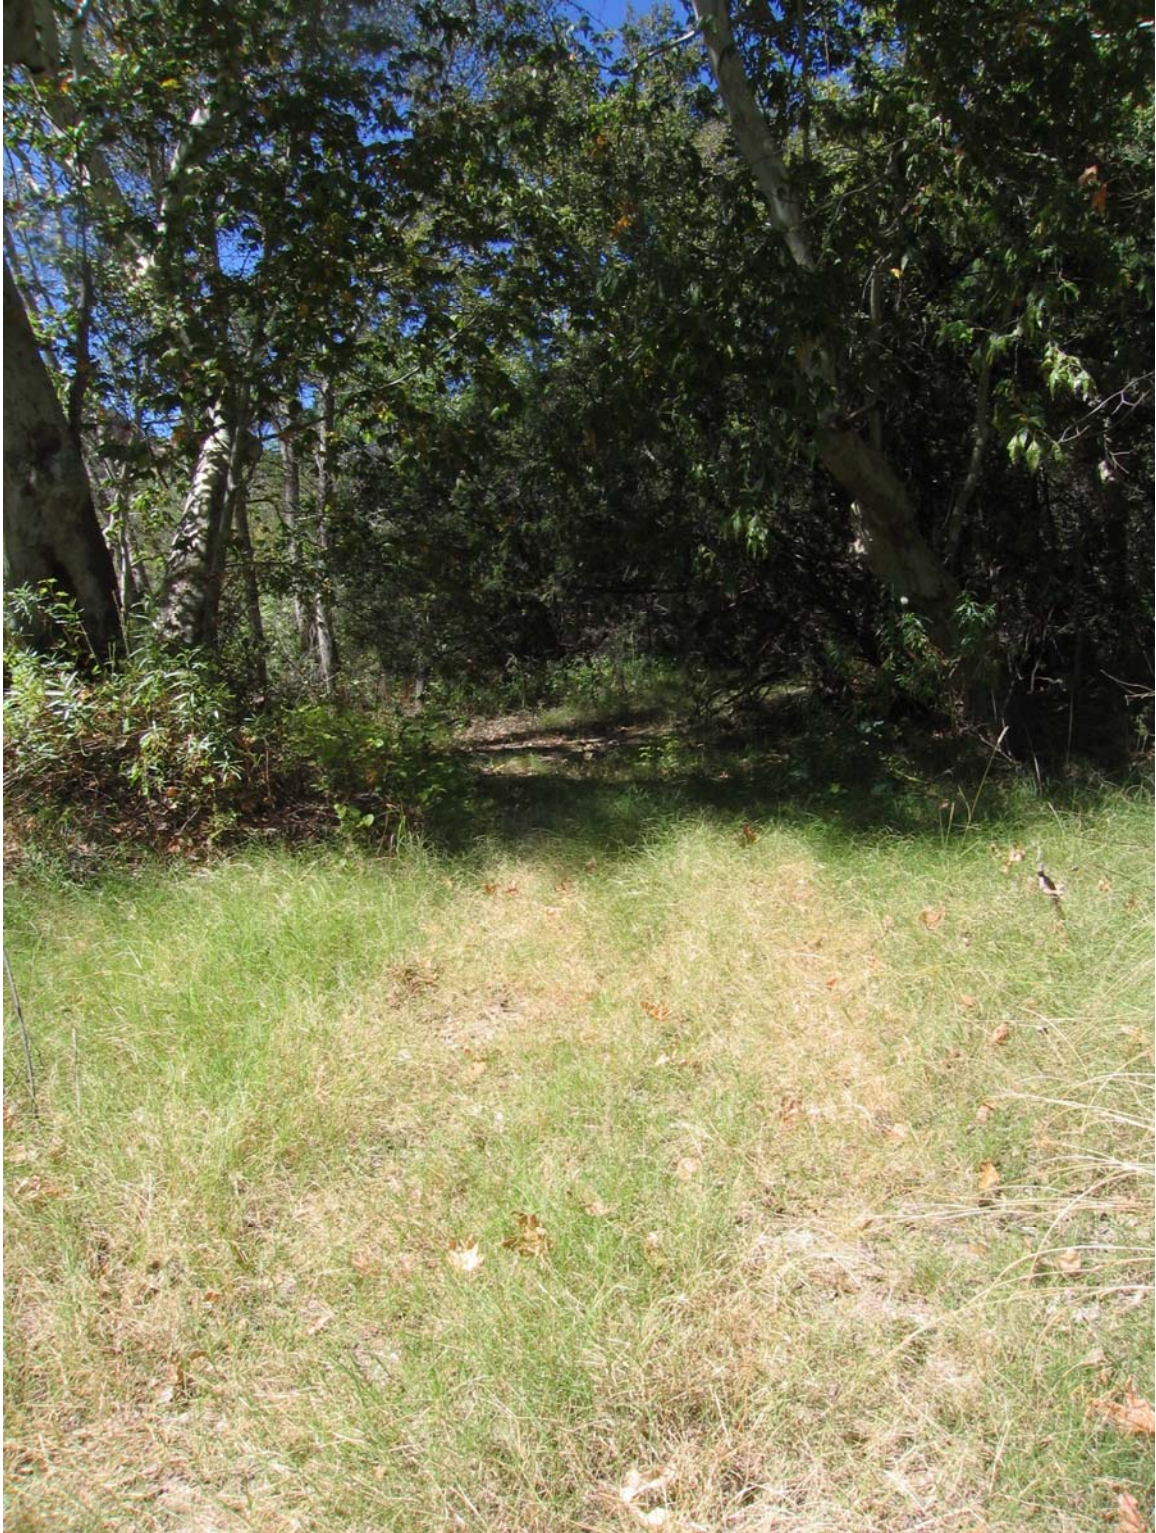
Photo 24. 12S 0695895//UTM 3677231. Trail travels along and above river on right side and heads to cave and fire pit.

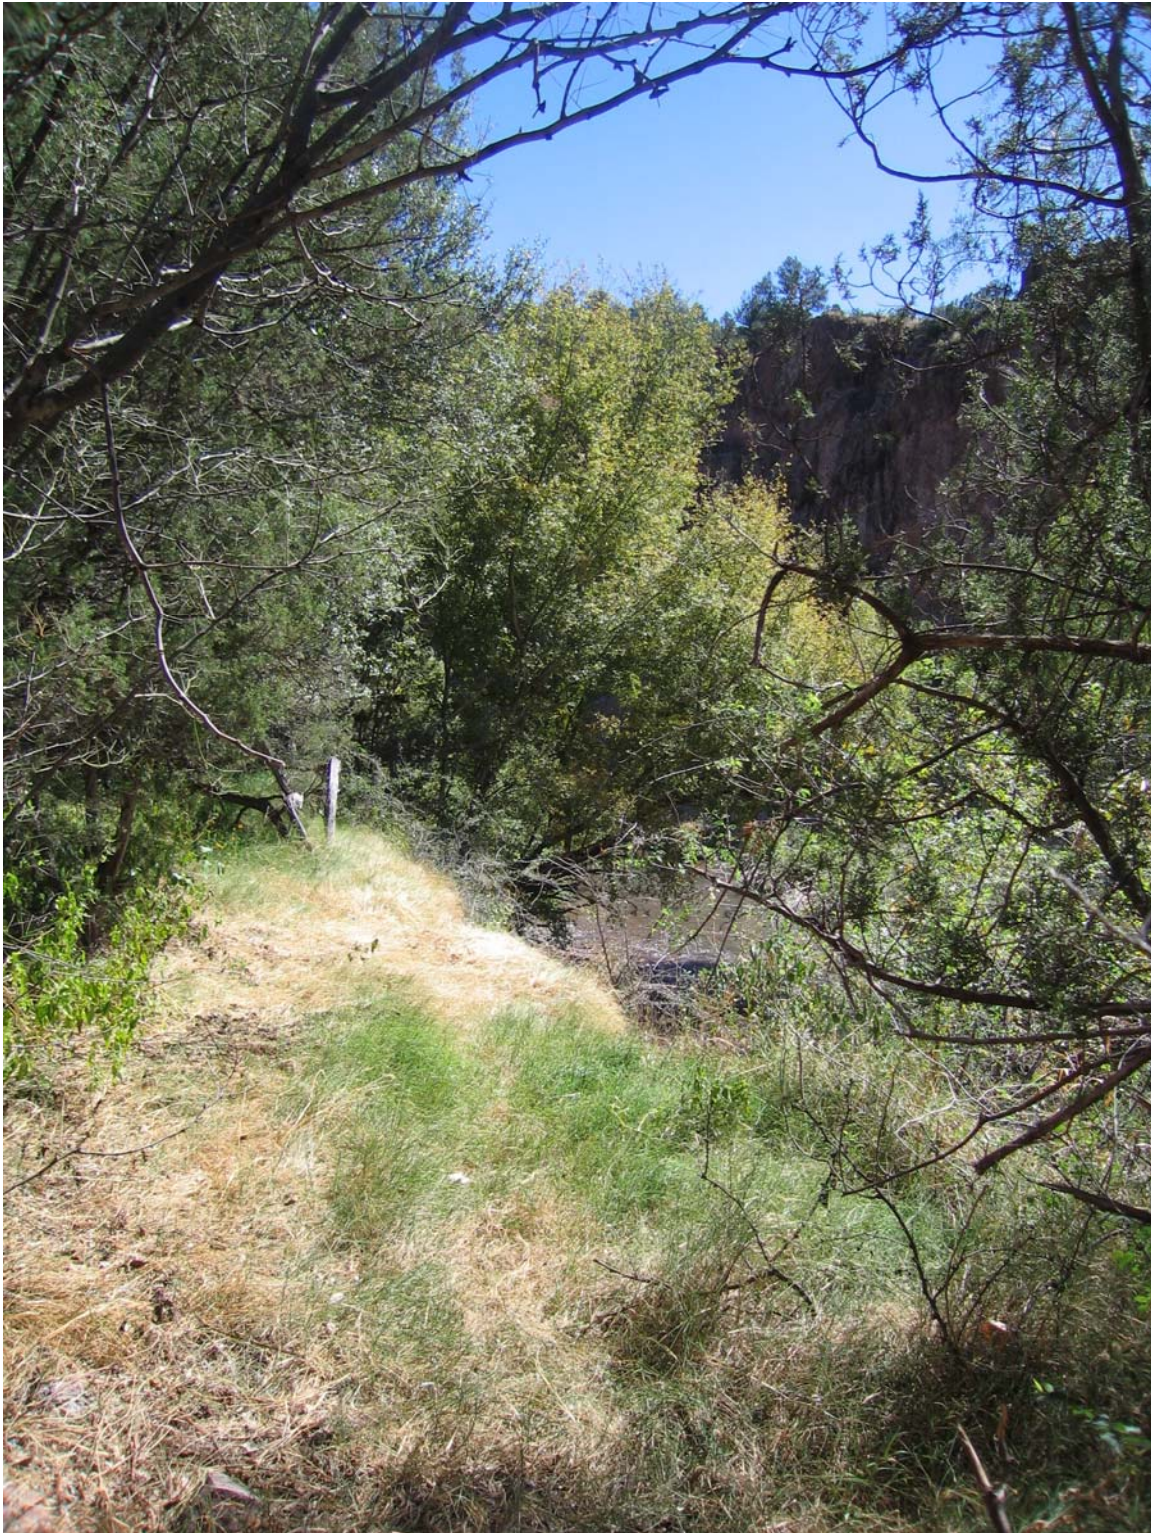
Photo 25. 12S 0695895//UTM 3677231- Another view of renegade route in photo 24.

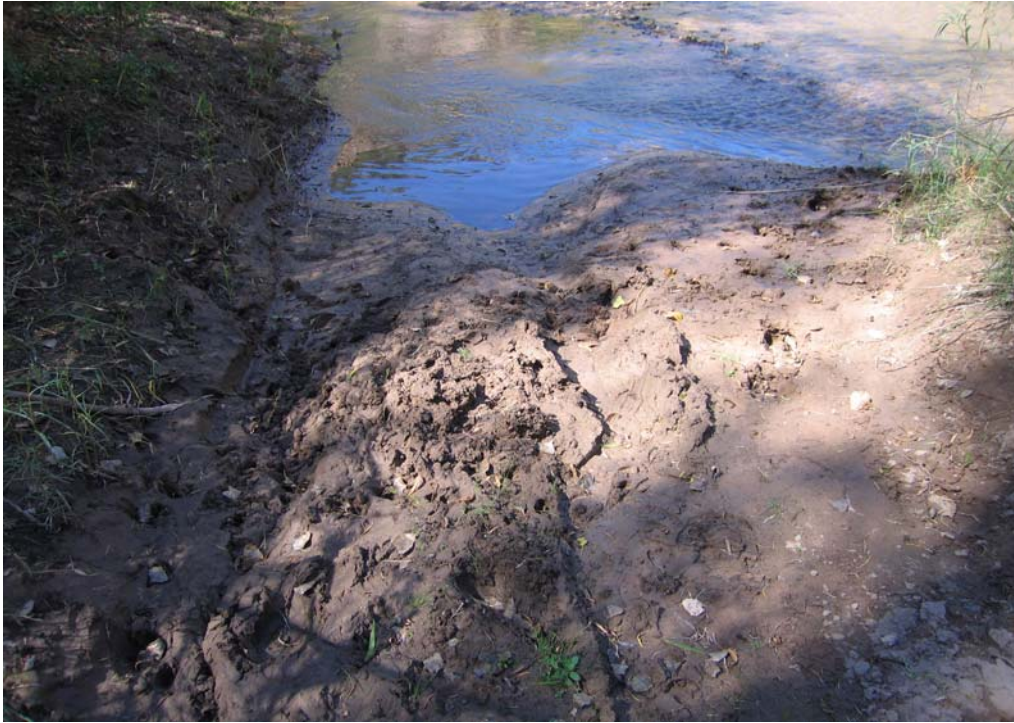
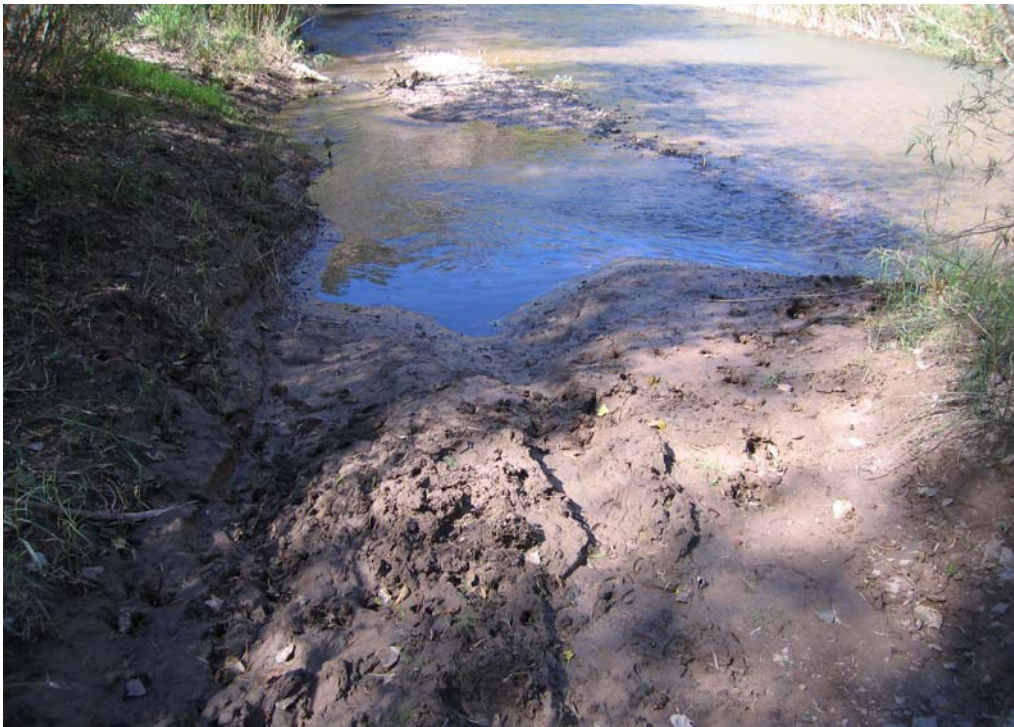
Photo 26 & 27, 12S 0695896//UTM 3677230 – Crossing further down river with significant evidence of livestock presence and off-road vehicle use. Note cumulative impacts of grazing and ORVs causing bank cutting, sedimentation, increased turbidity and likely loss of habitat.

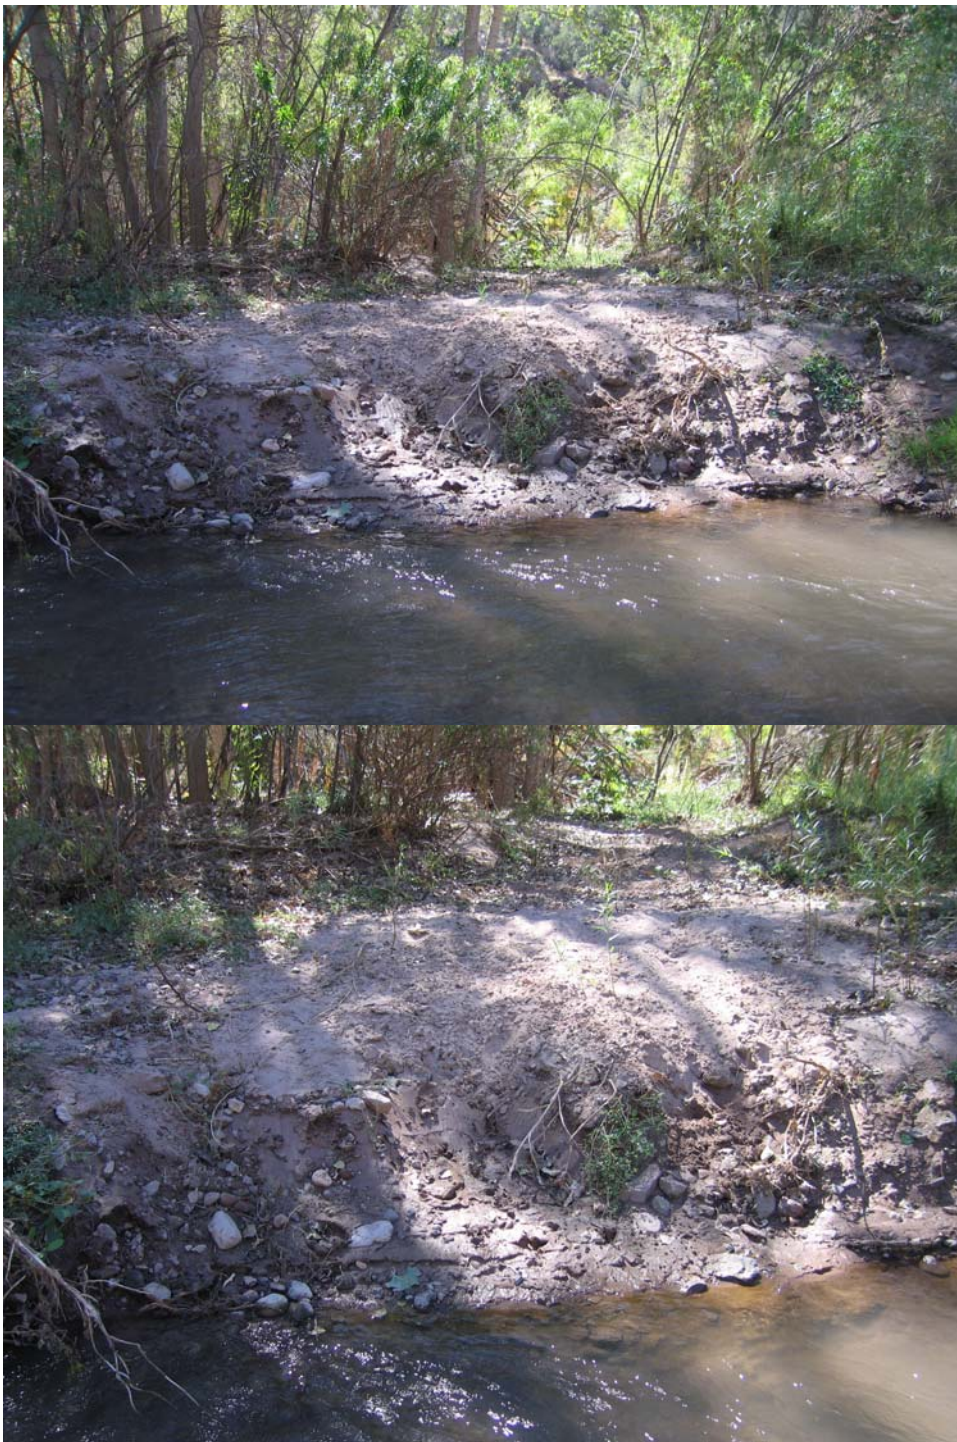
Photo 28 & 29. 12S 0695896//UTM 3677230 – Twenty feet downstream of 26 & 27 showing multiple tracks into river, cut banks, increased erosion & sedimentation due to livestock and off-road vehicles
