Appendix A: San Francisco River Photos – Gila National Forest

These photos accompany our request for closure to demonstrate both the outstanding ecological values associated with this area, as well as the ongoing damage due to ORV use in riparian areas. All photos were taken October 6 or 7, 2007 by Chris Kassar and all GPS points were taken using NAD 27 Datum. The photo point numbers match up with the red triangles found on the associated map of the area (Appendix C: Map #3- Gila NF Photo Points).

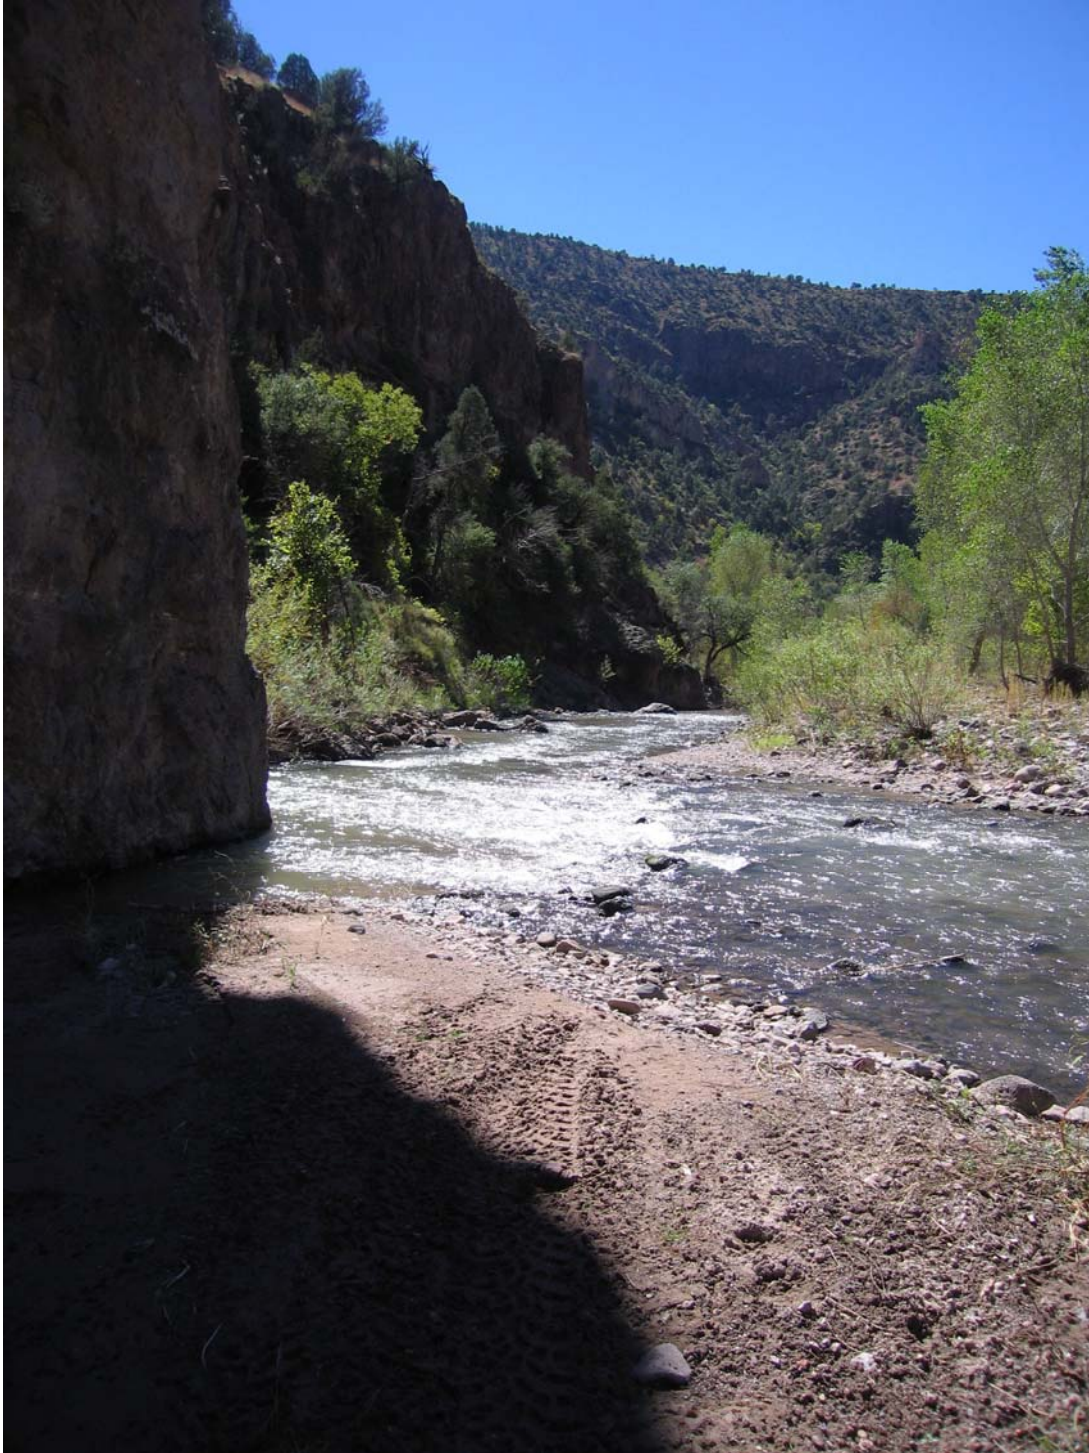
Photo 30. 12S 0695250//UTM 3677185 –Tracks traveling into river.
This is yet another point in the river where there is no other option, but for vehicles to drive directly in the water. River bottom is very unstable and there is significant evidence of erosion and turbidity.

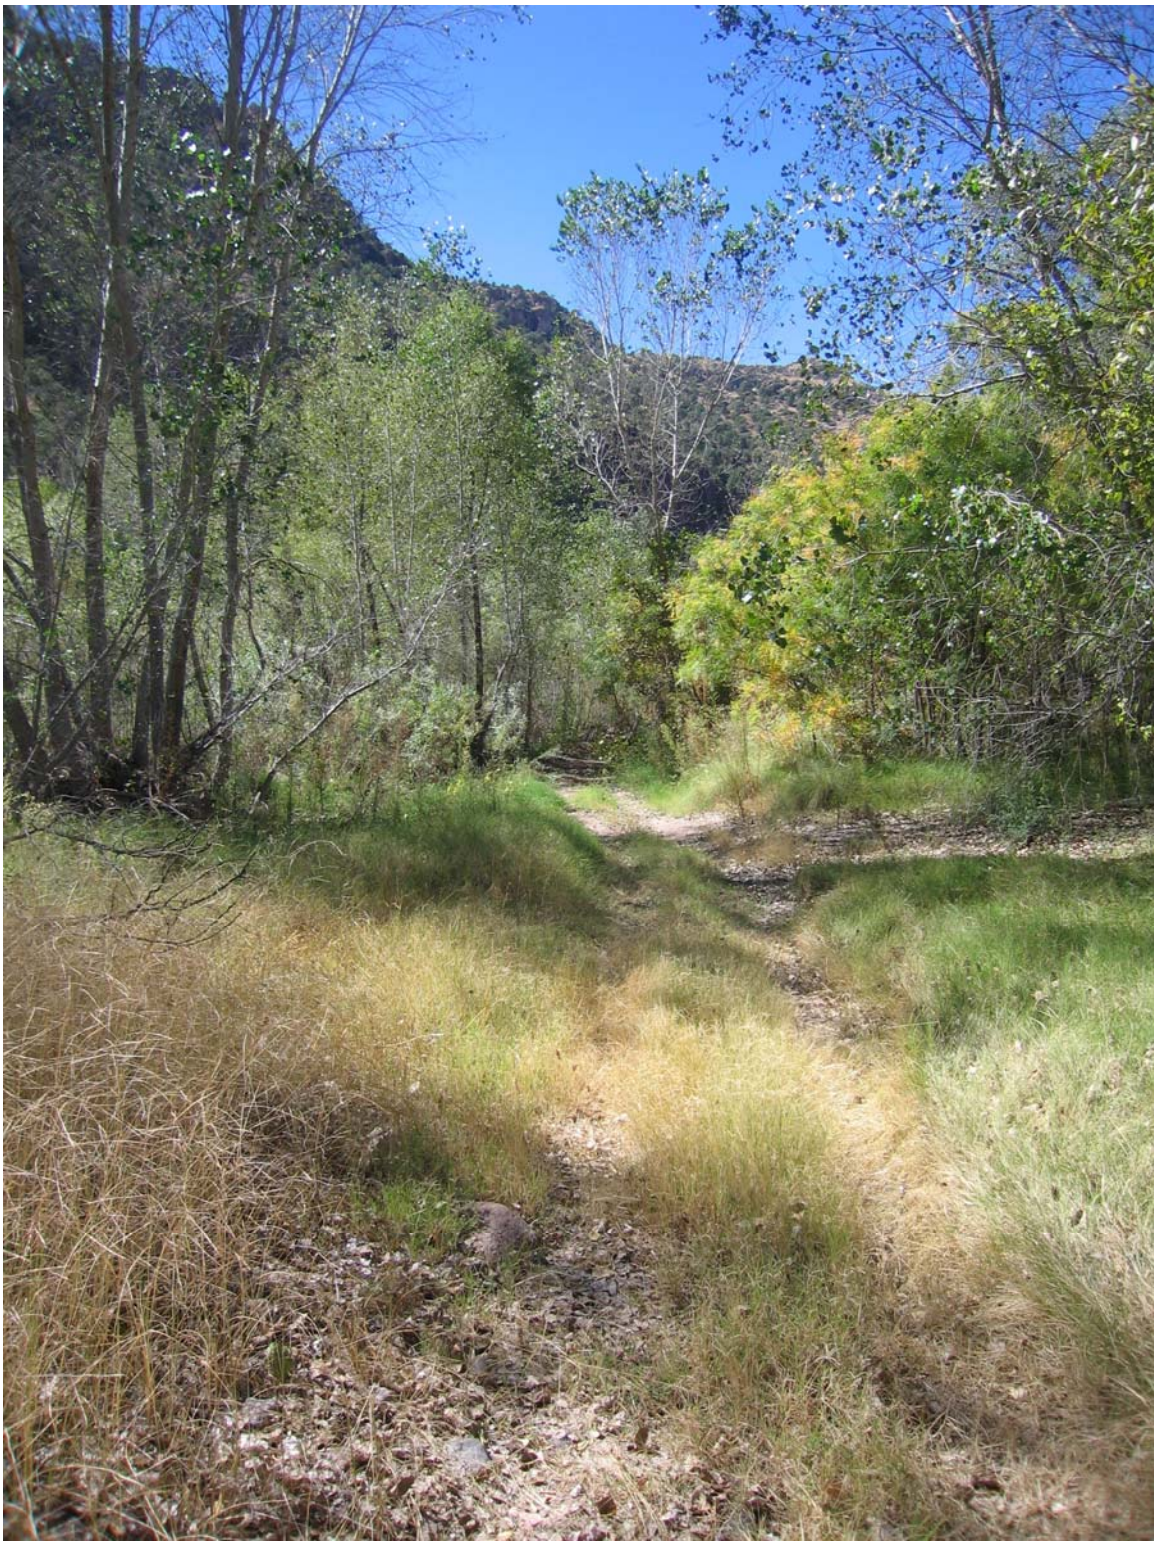
Photo 31. 12S 0695026//UTM 3676857– Tracks paralleling the river showing low use.

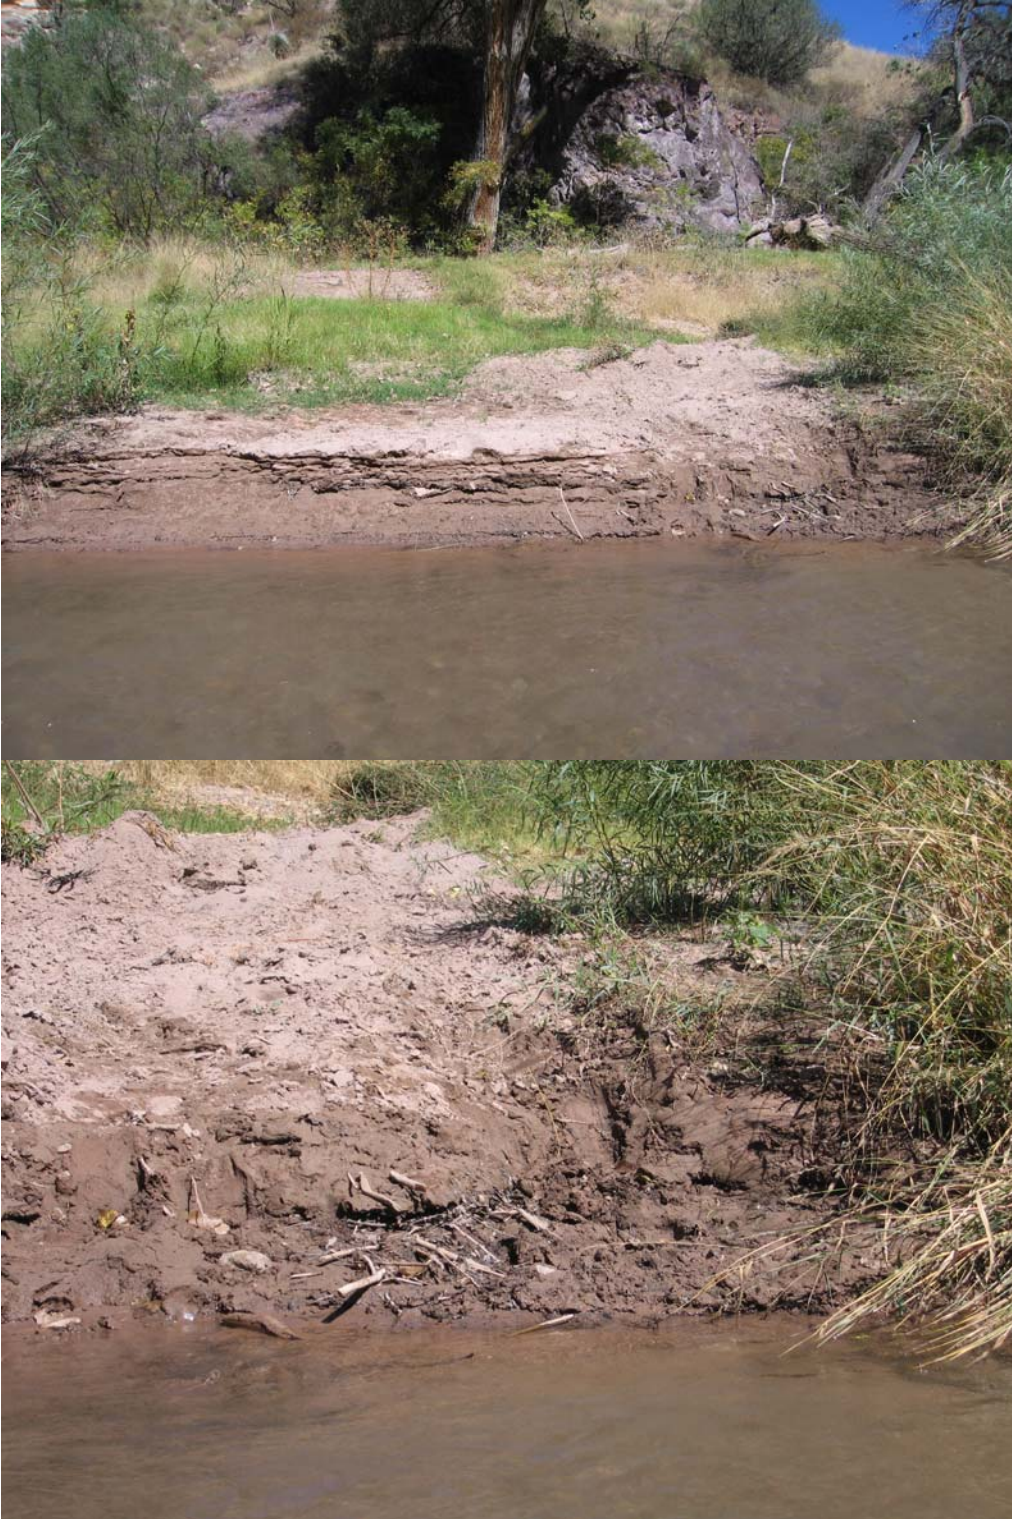
Photo 32 &33. 12S 0694959// UTM 3676849– Further downstream more evidence of livestock presence and off-road vehicle use. Note damage to bank and increased erosion.

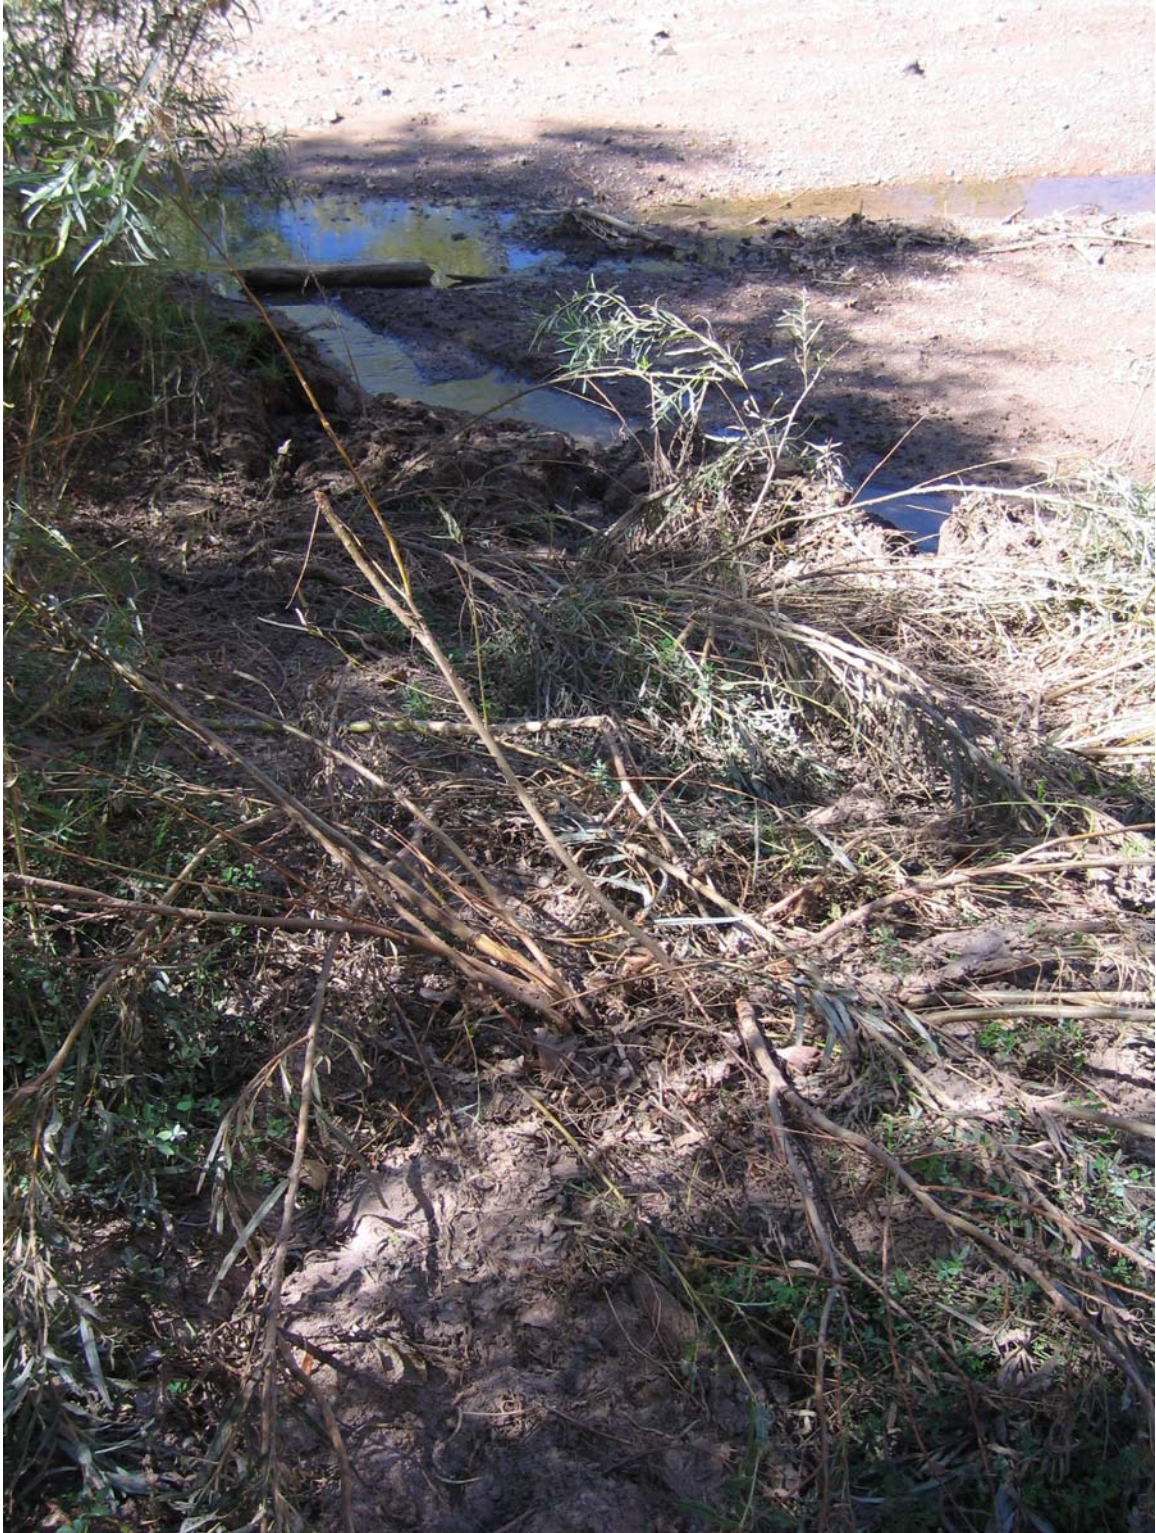
Photo 34. 12S 0694829//UTM 3676802– Vehicle tracks heading down to river. Note crushed vegetation and cow tracks.

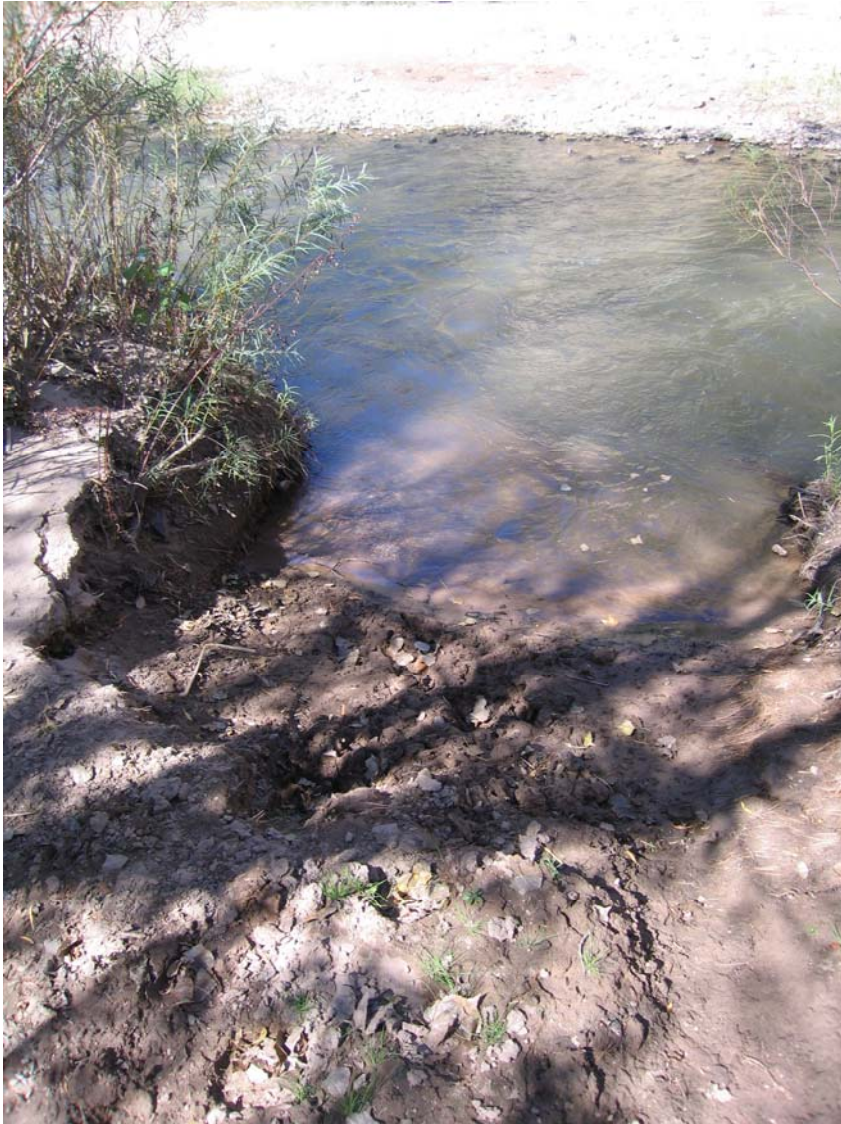
Photo 35. 12S 0694302//UTM 3677064 – Very muddy crossing with increased erosion, sedimentation and stream turbidity.

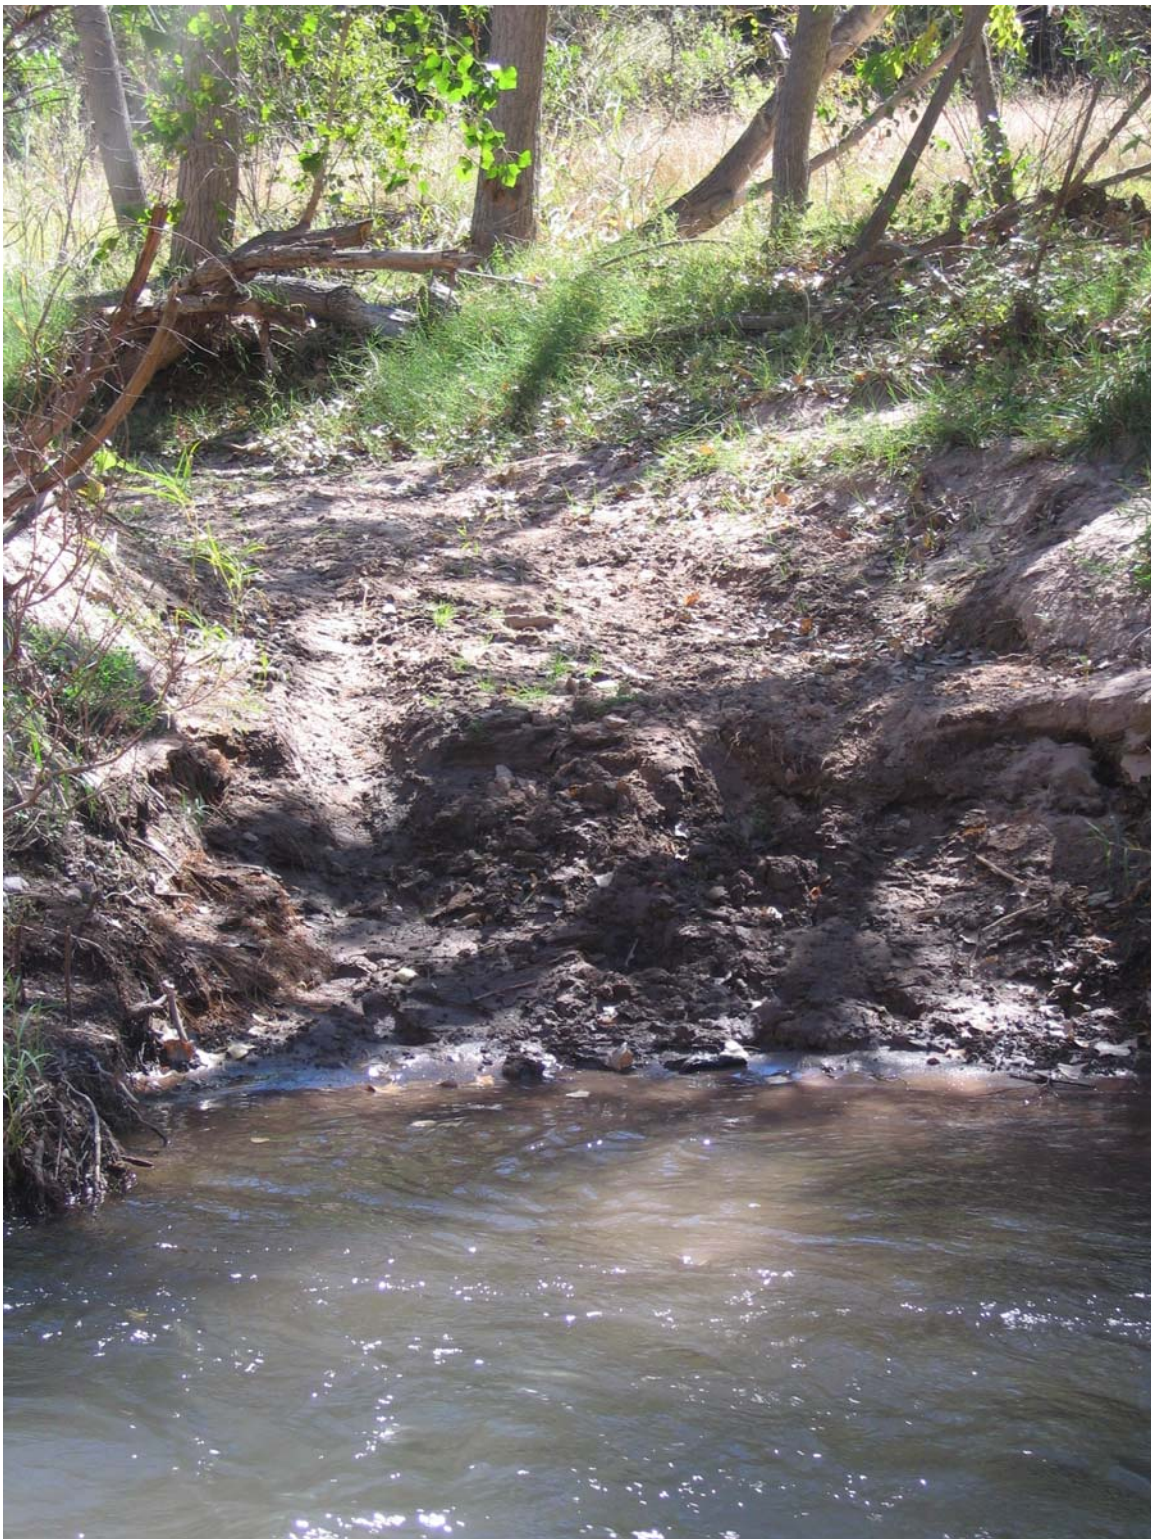
Photo 36. 12S 0694302//UTM 3677064 Very muddy crossing with increased erosion, sedimentation and stream turbidity.

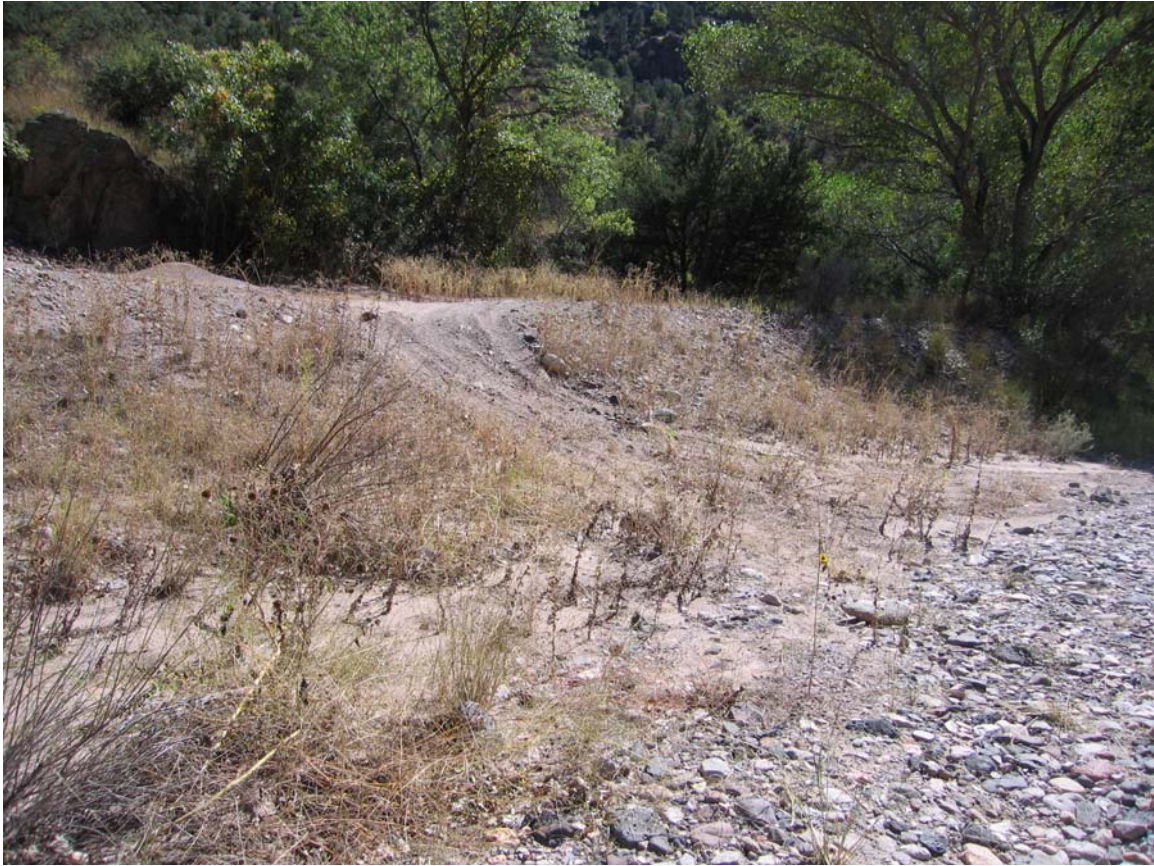
Photo 37. 12S 0693802//UTM 3677122- Proliferation of routes off of the bank of the San Francisco River. There are tracks heading up to left and away from river as well as those heading toward the river (next photo).

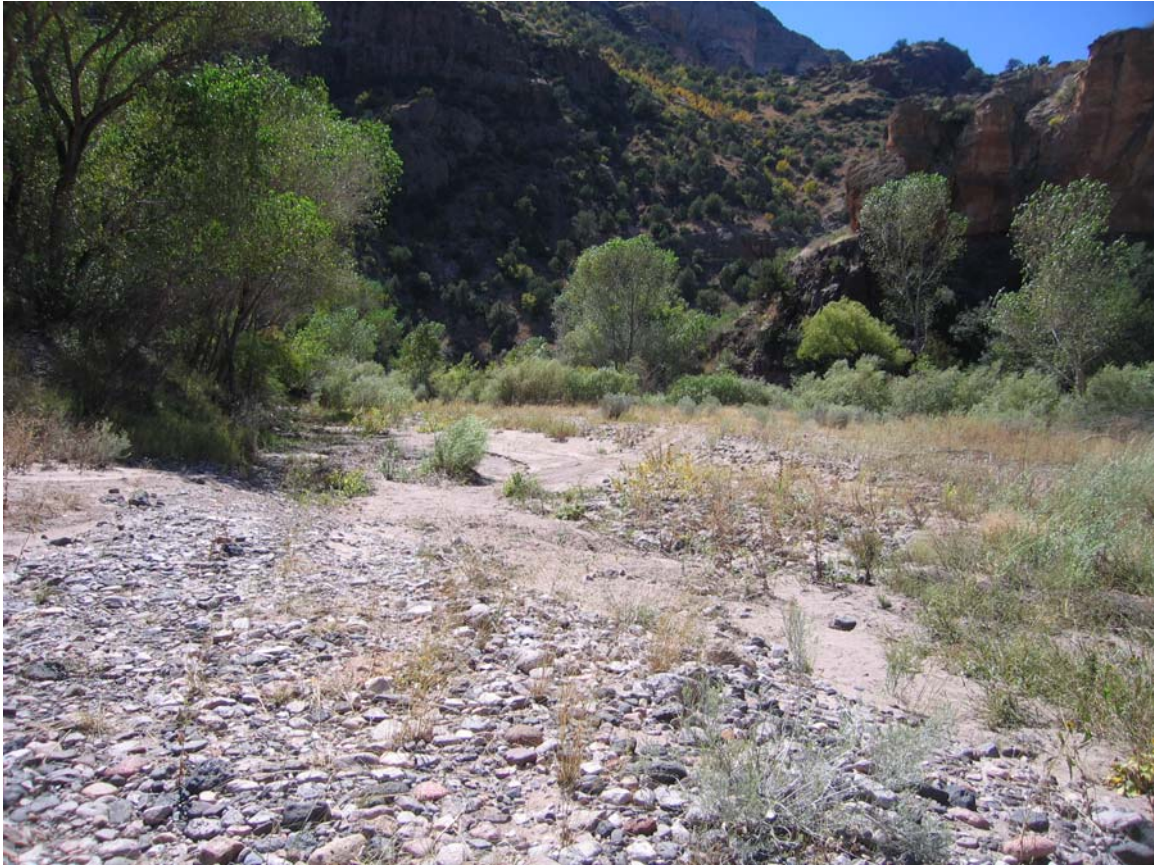
Photo 38. 12S 0693802//UTM 3677122- Proliferation of routes off of the bank of the San Francisco River. There are tracks heading up to left and away from river (previous photo) as well as those heading toward the river as in this photo.

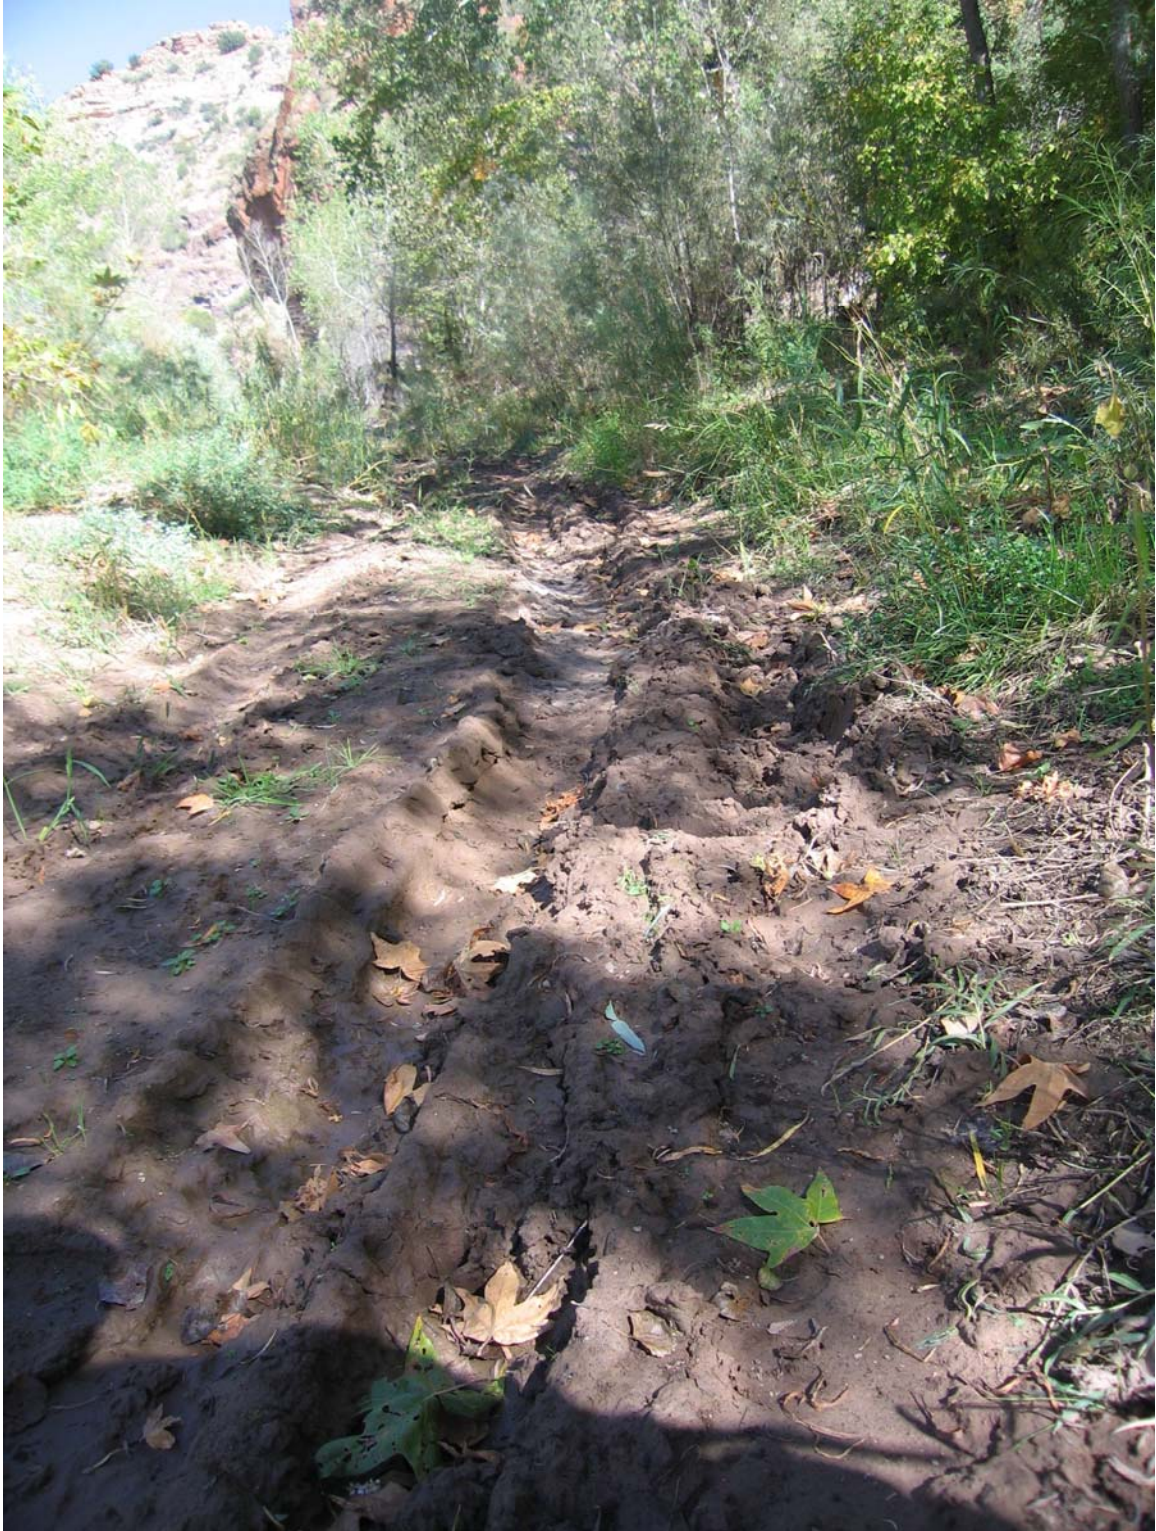
Photo 39. 12S 0693012//UTM 3677021 – Vehicle tracks adjacent to river. Note extreme ruts (1 to 1.5 feet in depth) and muddiness, as well as livestock tracks.

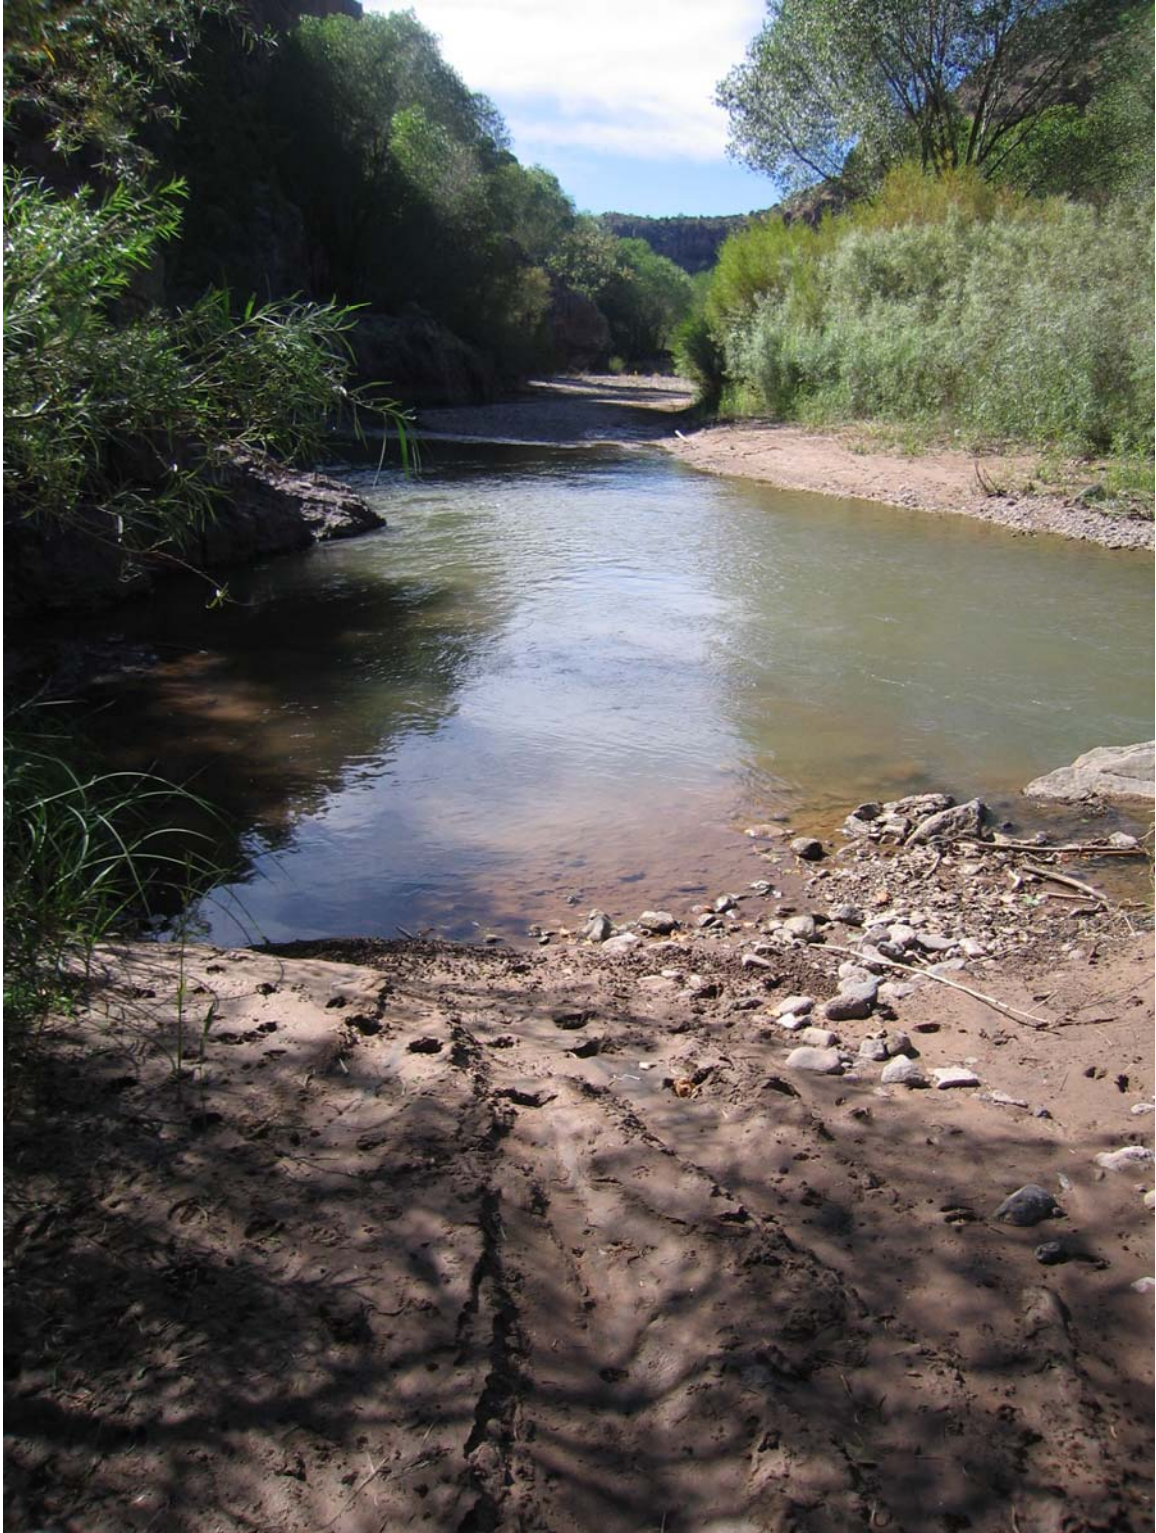
Photo 40. 12S 0693012//UTM 3677021 – Vehicle tracks into river. Note extreme ruts (1 to 1.5 feet in depth) and muddiness, as well as livestock tracks.

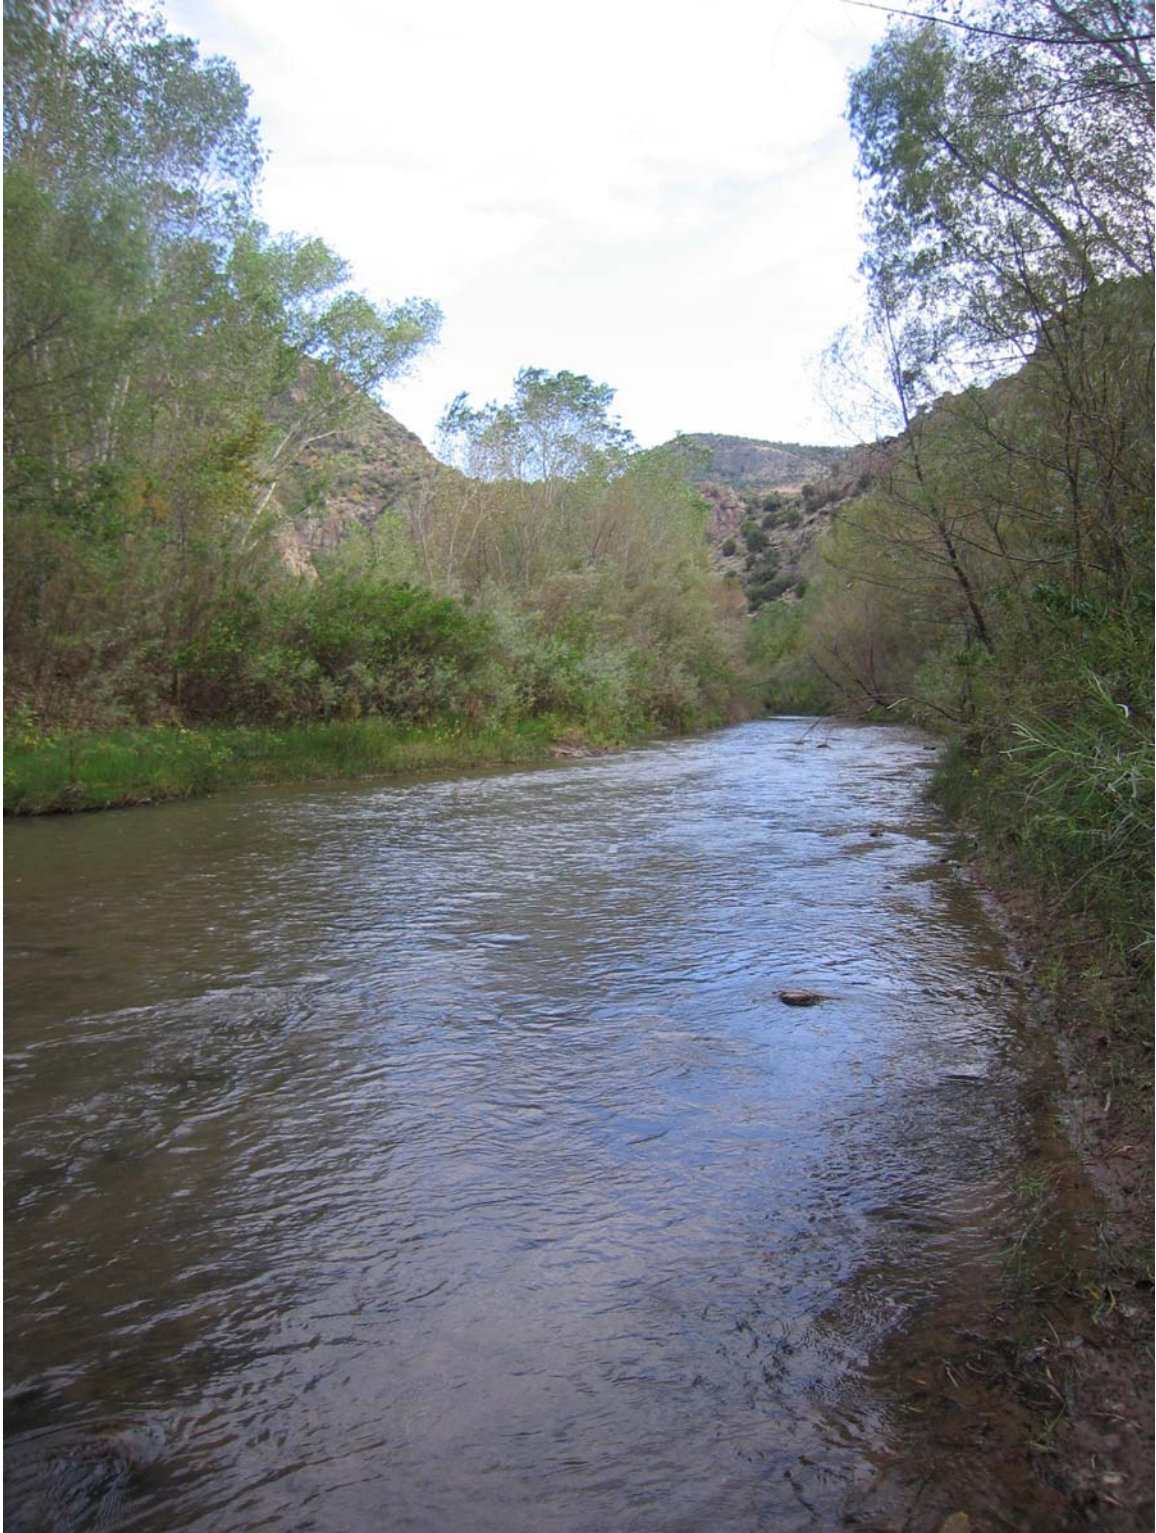
Photo 41. 12S 0693012//UTM 3677021 – Photo of river showing ecological values that need to be preserved, including healthy riparian vegetation and potential habitat for fish, birds and mammals.
